ASBESTOS AND LEAD BASED PAINT SURVEY

First Baptist Church
101 Broadway Blvd NE
Albuquerque, New Mexico

April 8, 2014
Project No. 14-001

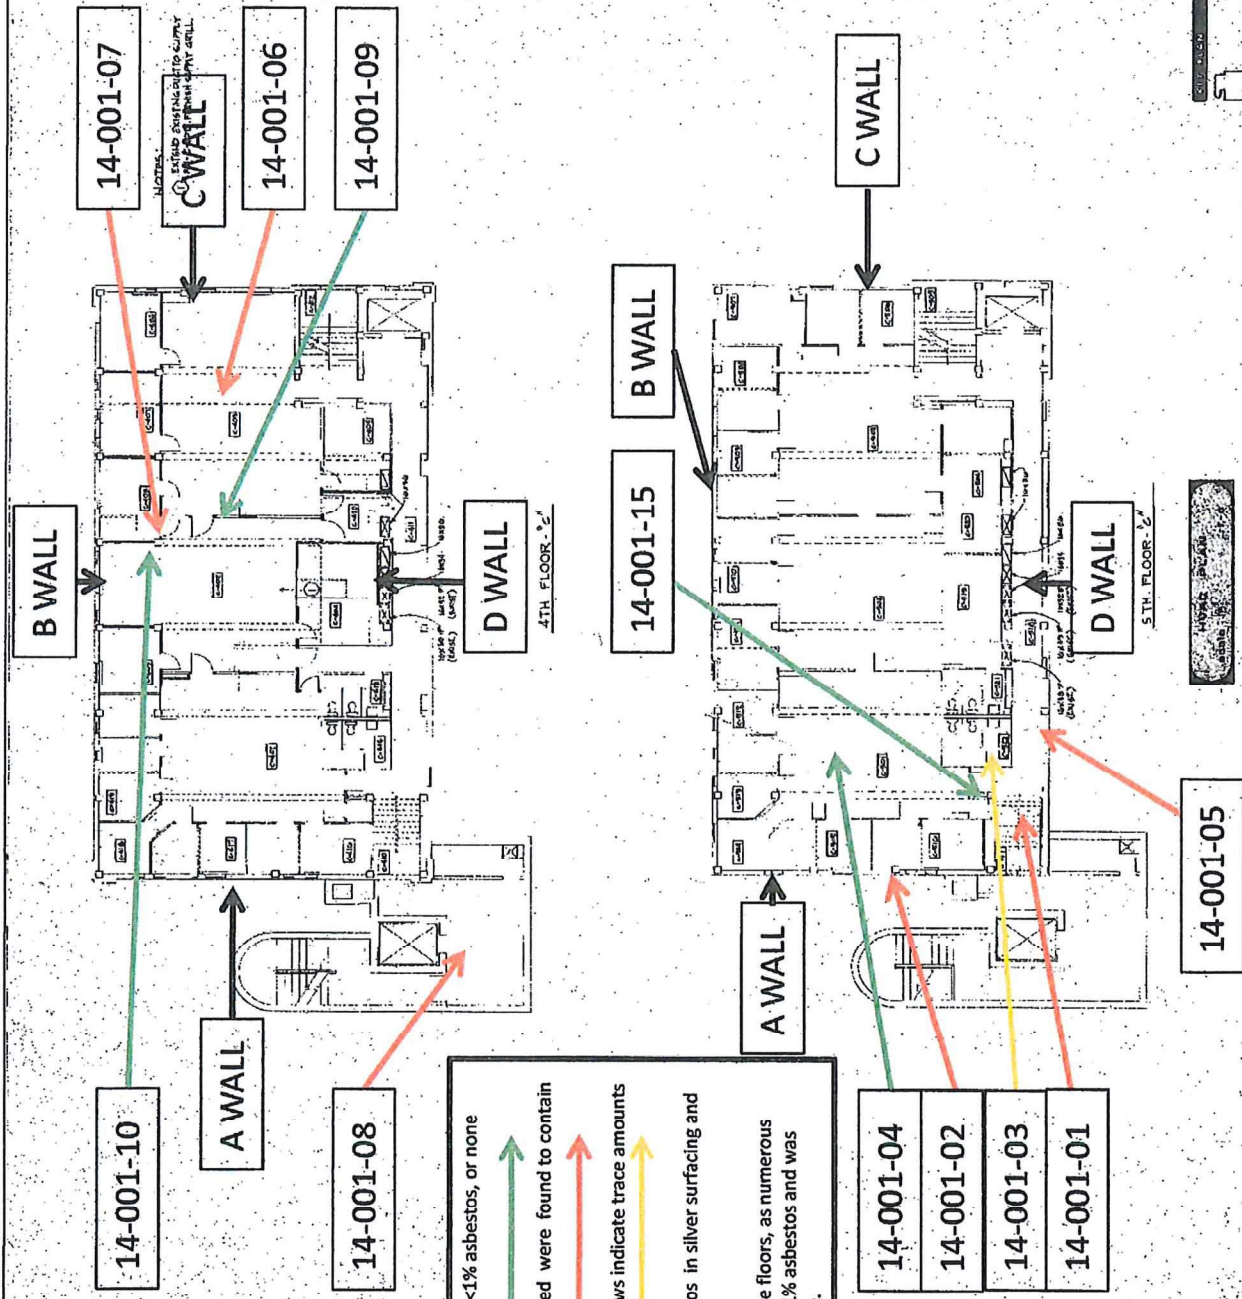
Samples with red arrows and boxed were found to contain >1% asbestos.

Roofing samples indicated asbestos in silver surfacing and black tar roofing materials.

Black Mastic is assumed on all five floors, as numerous black mastic samples indicated >1% asbestos and was uniform throughout the structure.

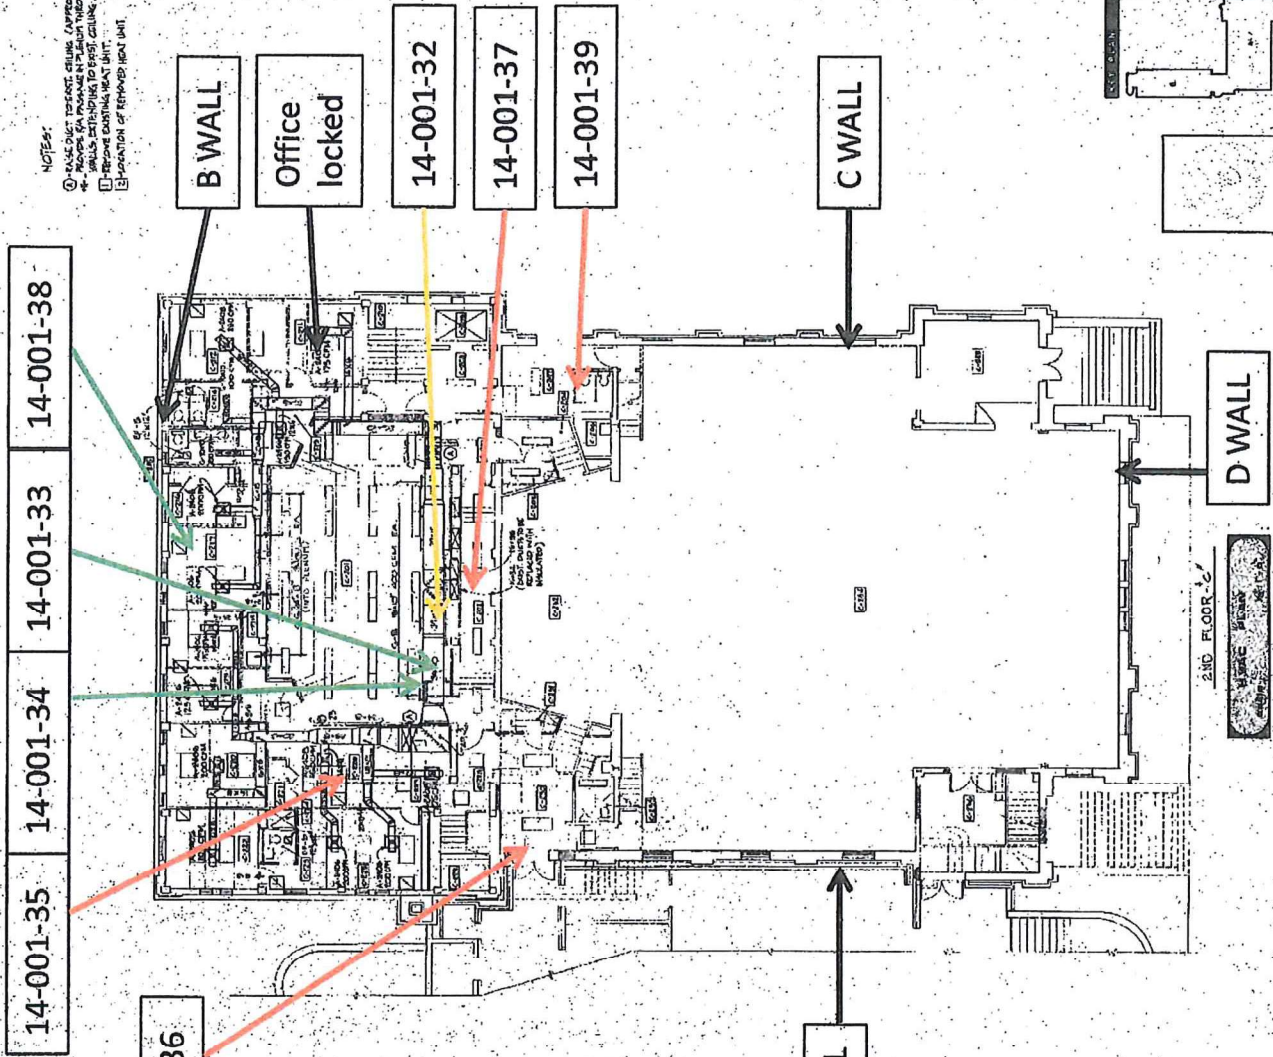
Samples with green arrows were <1% asbestos, or none was detected. ↑

Samples with red arrows and boxed were found to contain >1% asbestos. ↑

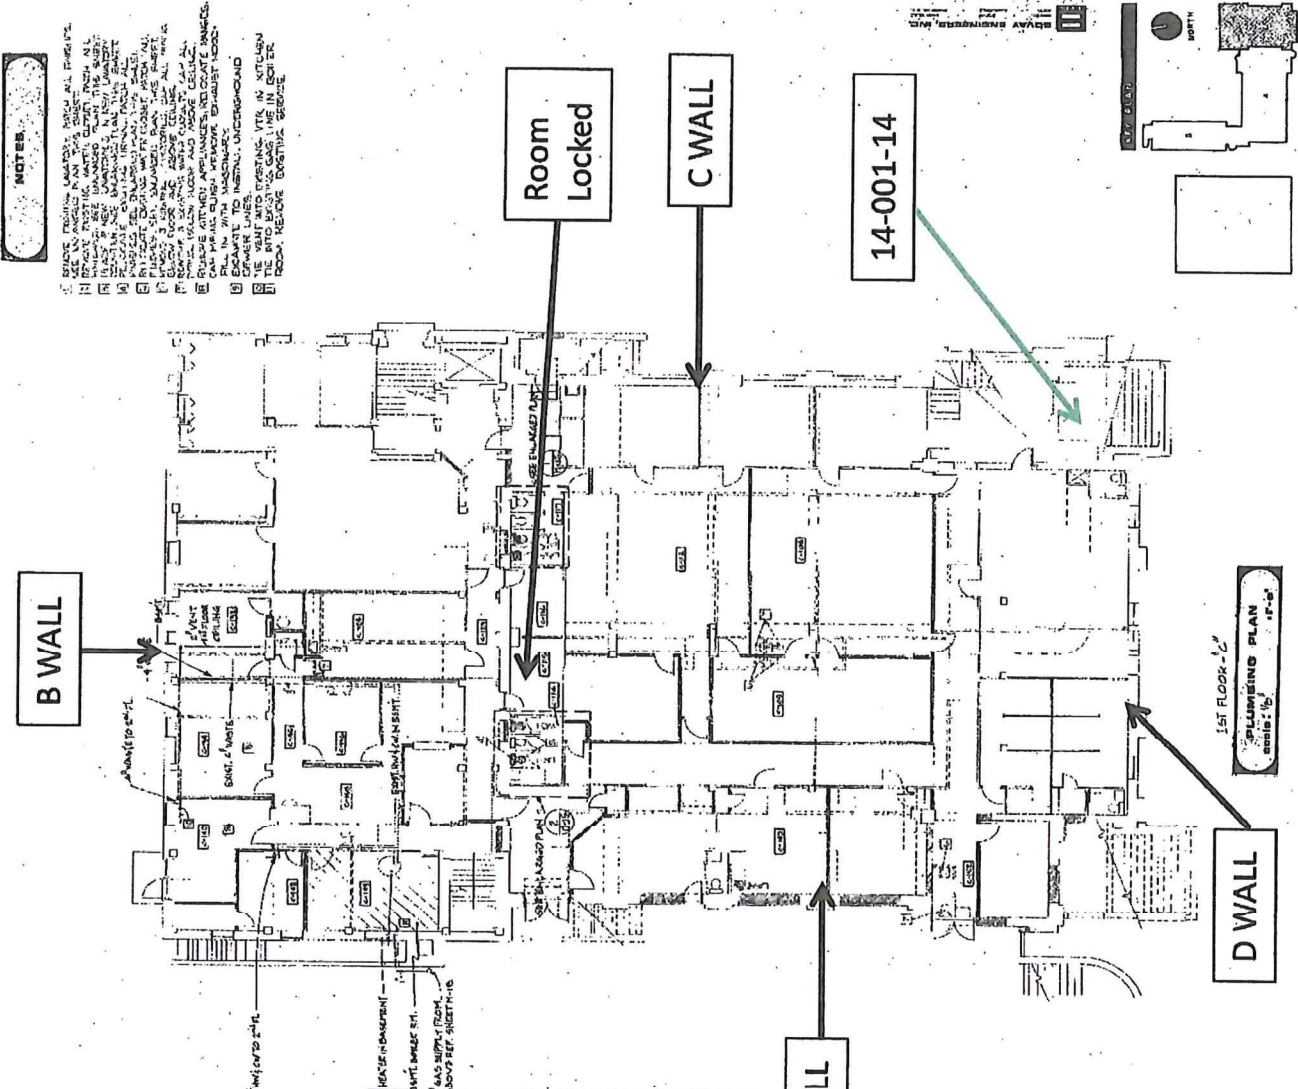
Samples with red arrows and boxed were found to contain >1% asbestos.

Roofing samples indicated asbestos in silver surfacing and black tar roofing materials.

Black Mastic is assumed on all five floors, as numerous black mastic samples indicated >1% asbestos and was uniform throughout the structure.

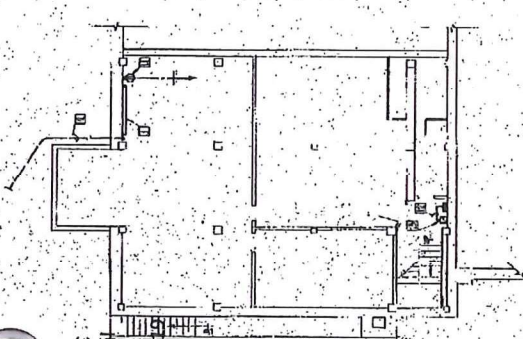
BASEMENT PLAN - EXISTING BUILDING

XRF device samples are depicted by a green arrow.
 Physical lead samples taken are depicted by an orange arrow. At 0.2%, all lead samples taken are within regulatory guidelines. All lead samples had concentrations of less than 0.2%.

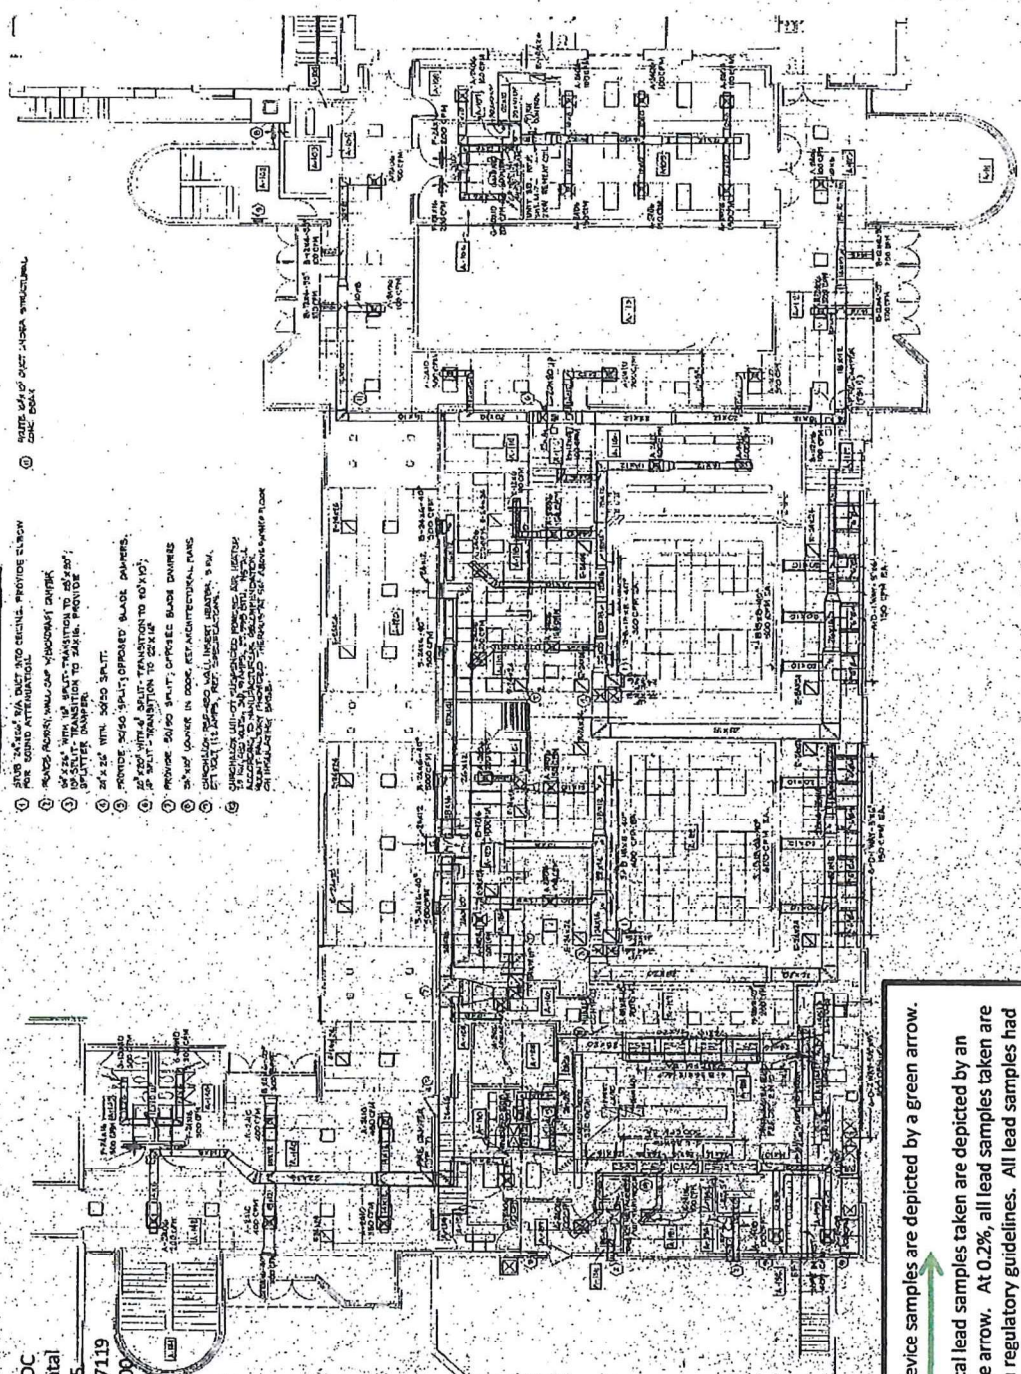
1ST FLOOR PLAN

XRF device samples are depicted by a green arrow.
Physical lead samples taken are depicted by an orange arrow. At 0.2%, all lead samples taken are within regulatory guidelines. All lead samples had concentrations of less than 0.2%.

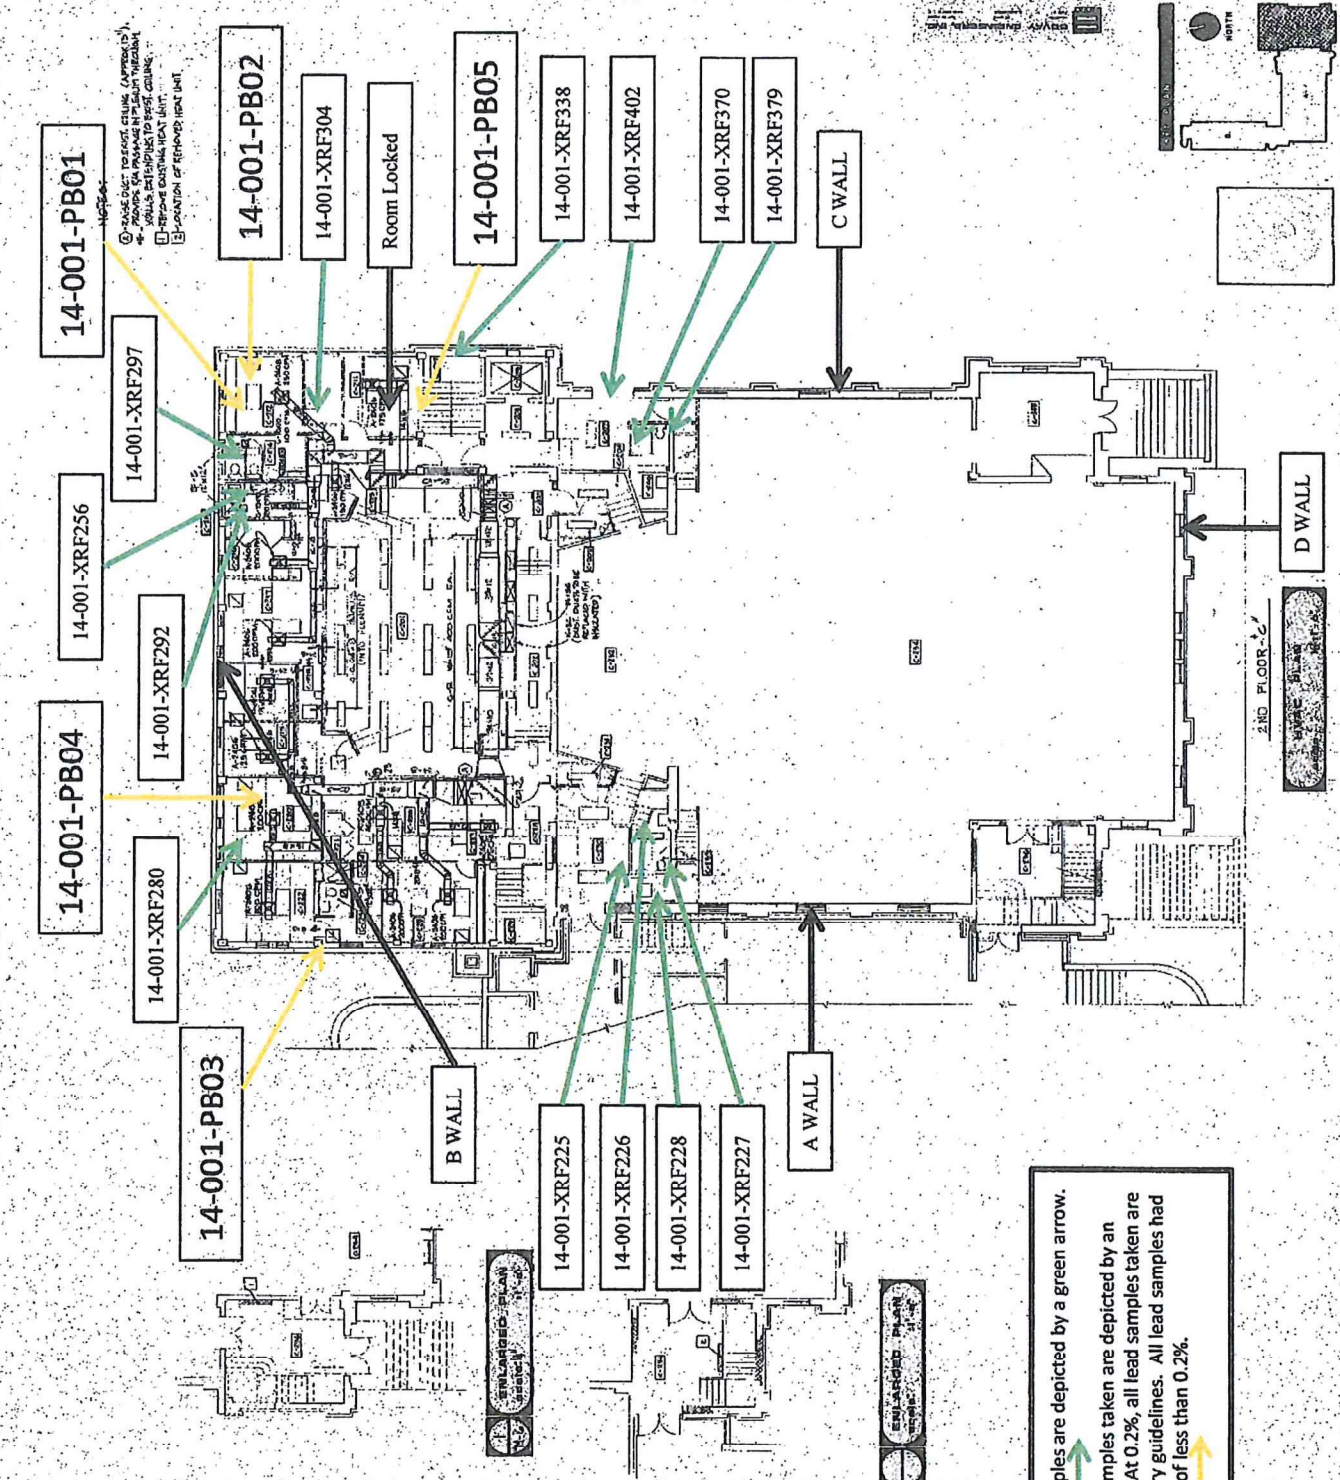
XRF device samples are depicted by a green arrow.
 Physical lead samples taken are depicted by an orange arrow. At 0.2%, all lead samples taken are within regulatory guidelines. All lead samples had concentrations of less than 0.2%.

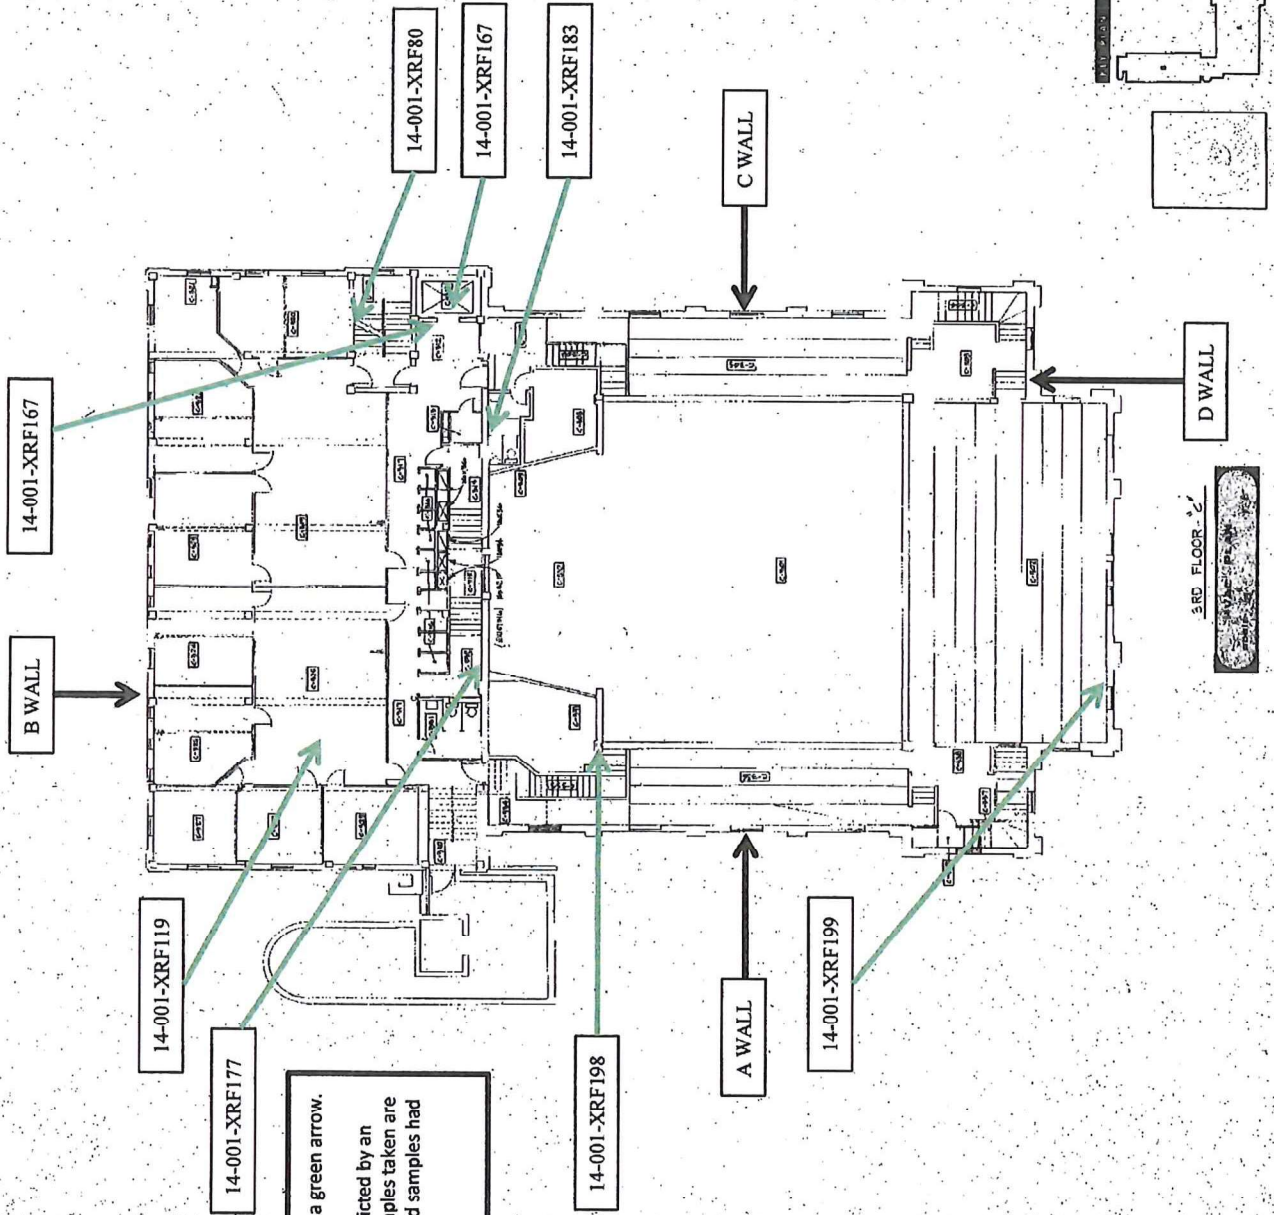
XRF device samples are depicted by a green arrow.
 Physical lead samples taken are depicted by an orange arrow. At 0.2%, all lead samples taken are within regulatory guidelines. All lead samples had concentrations of less than 0.2%.
