ENVIRONMENTAL INSPECTION REPORT

**1801 Las Lomas NE
Albuquerque, NM**

ASBESTOS INSPECTION REPORT

RE: Limited Lead Paint Chip Sampling
1801 Las Lomas NE

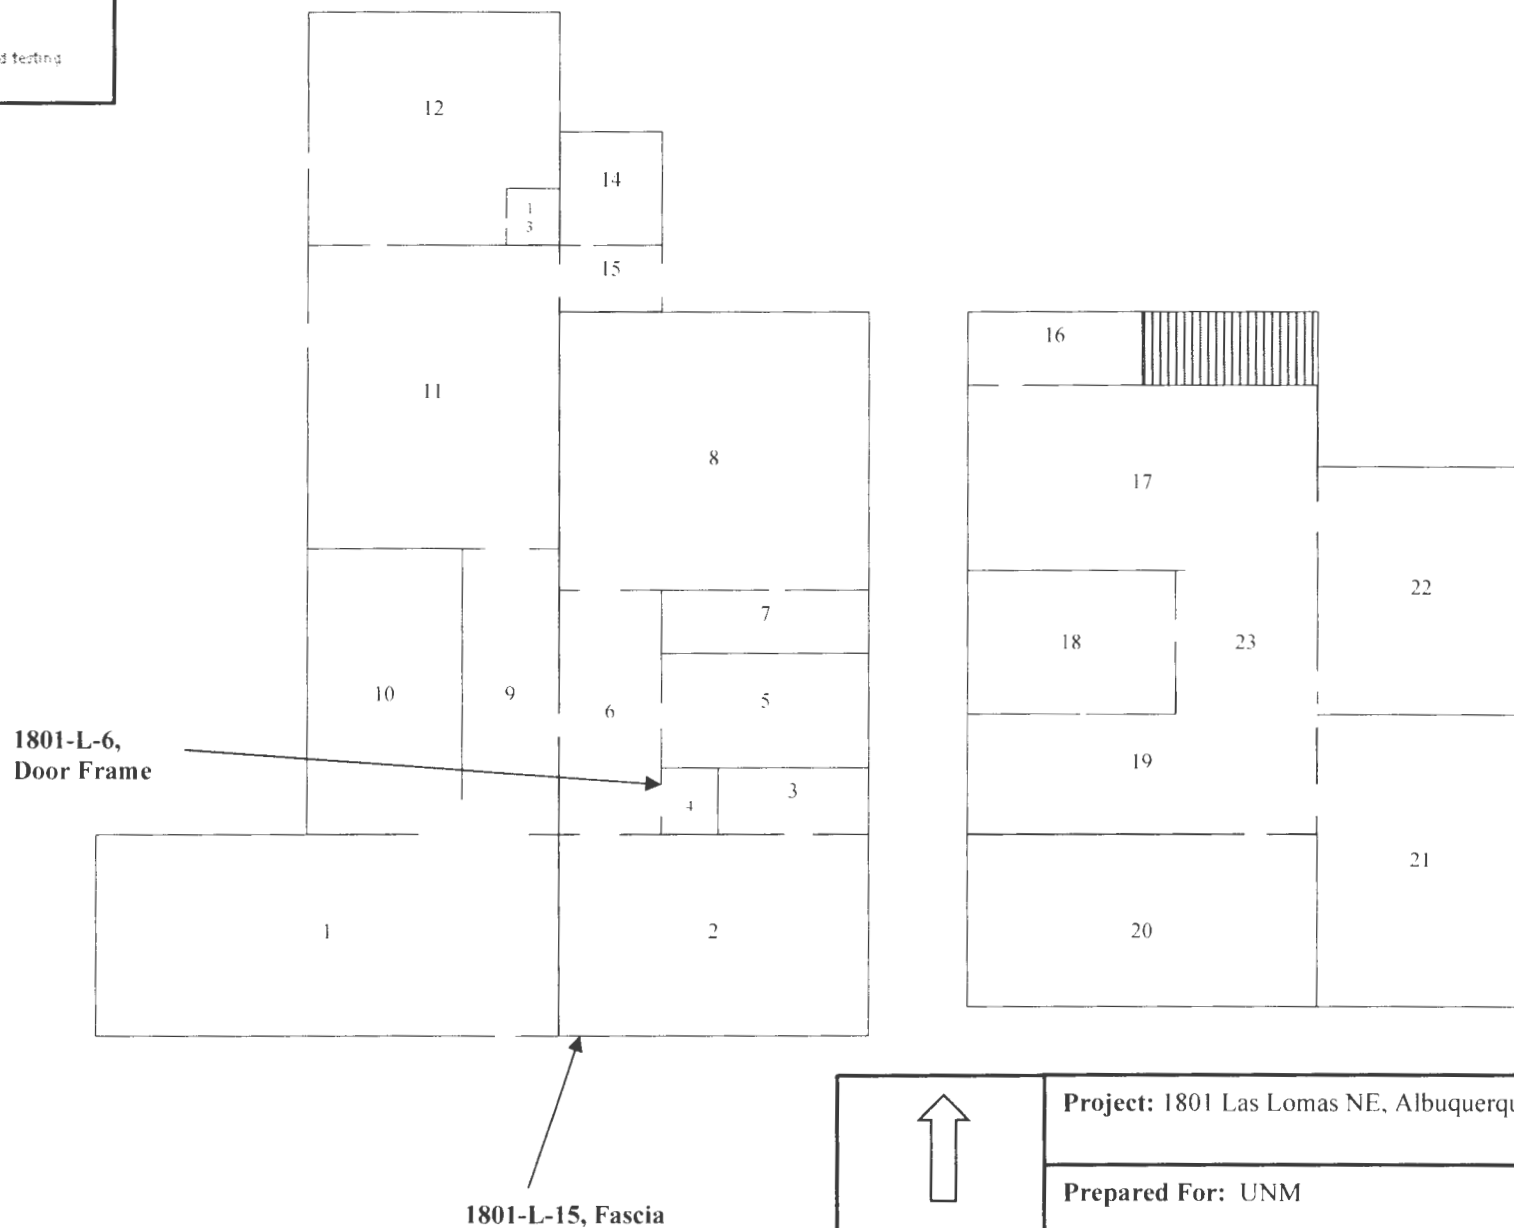
LEAD BASED PAINT LOCATION DIAGRAM

- Of the paint chip samples collected, four two were identified to be above the federal lead standard of 0.5% lead by weight. Refer to Appendix A for positive sample locations.
- Refer to Appendix B for Laboratory Results.

1801-L-6,
Door Frame

1801-L-15, Fascia
