SURVEYOR'S INSPECTION REPORT

THAT ON JUNE 17, 1996, I MADE AN ACCURATE INSPECTION OF THE PREMISES SITUATED AT ALBUQUERQUE, BERNALILLO COUNTY, NEW MEXICO, BRIEFLY DESCRIBED AS:

1713 LAS LOMAS ROAD, N.E.

Lot numbered Two (2) in Block numbered Nineteen (19) of the COUNTRY CLUB ADDITION to the City of Albuquerque, New Mexico, as the same is shown and designated on the Map of said addition, filed in the office of the County Clerk of Bernalillo County, New Mexico on June 7, 1923 in Volume D1, folio 36.

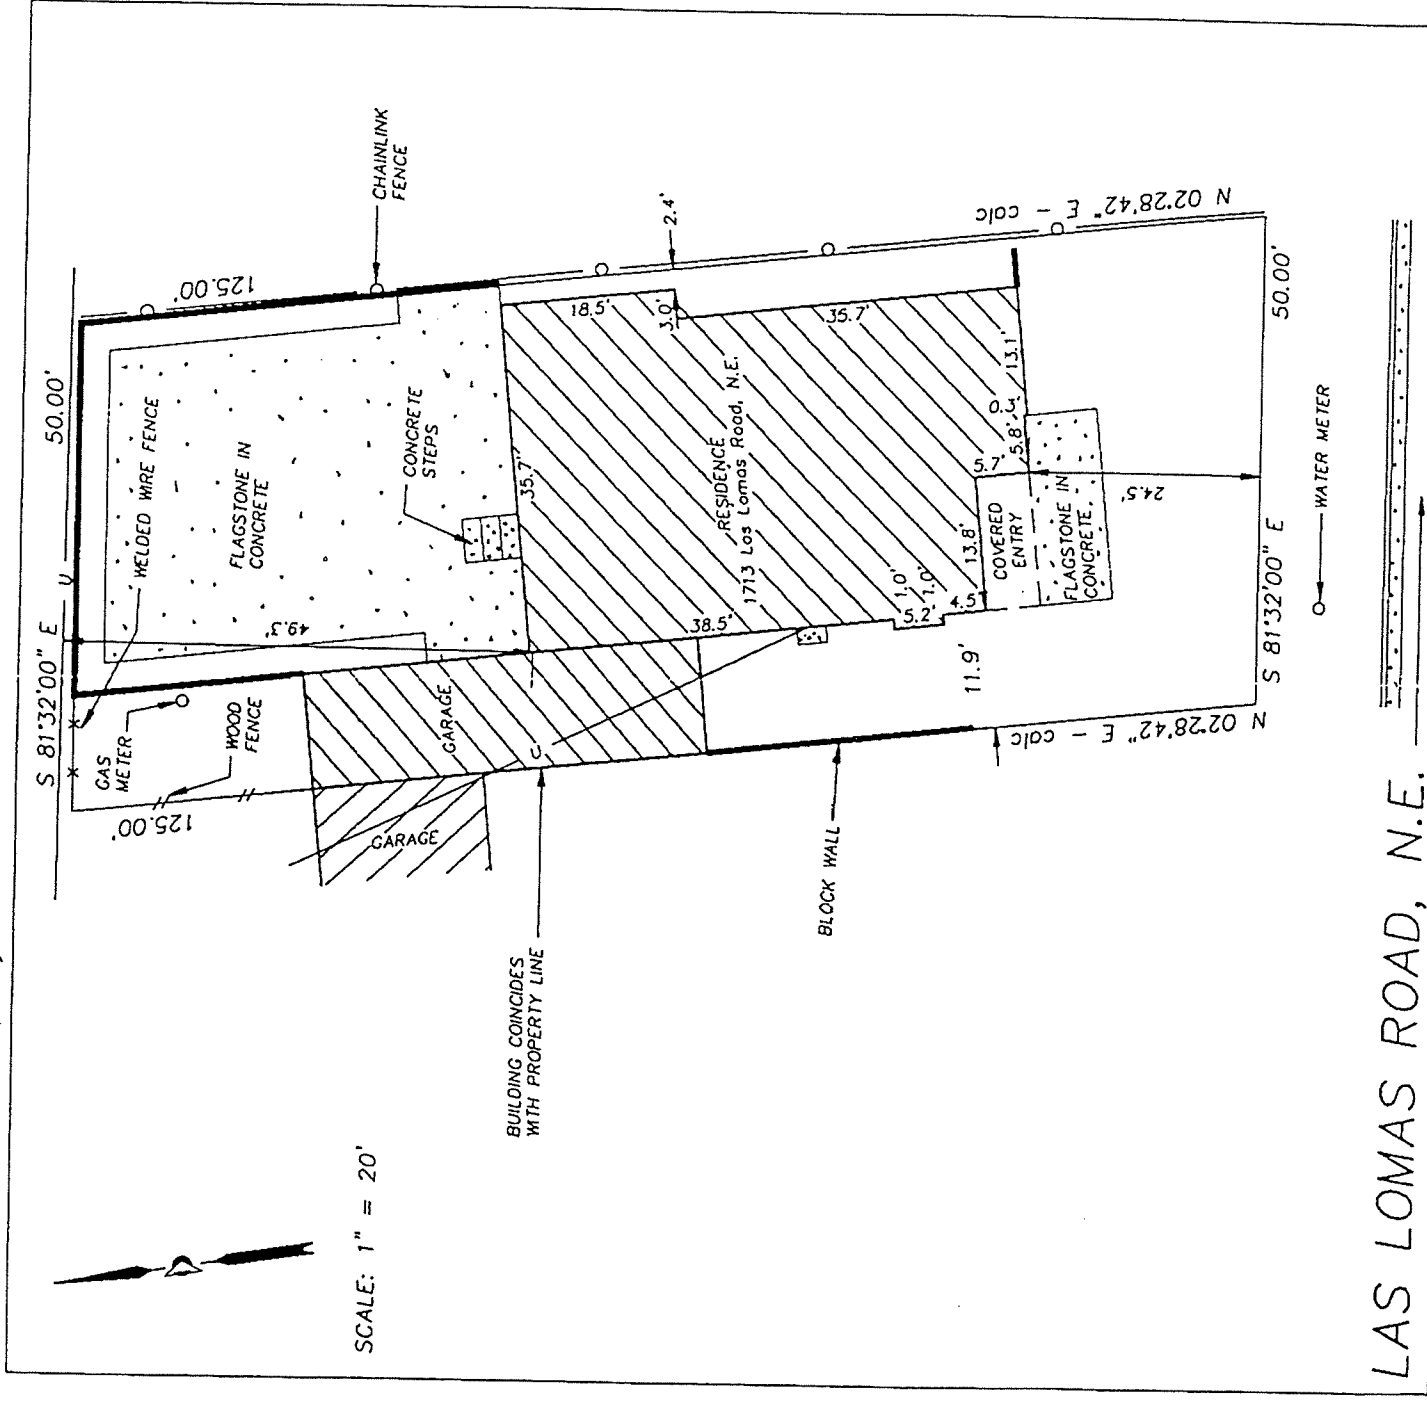
1. Evidence of rights of way, old highways or abandoned roads, lanes, trails or driveways, sewer, drains, water, gas or oil pipe lines on or crossing said premises  
see sketch

4. Overhead utility poles, anchors, pedestals, wires or lines overhanging or crossing said premises and serving other properties:  
see sketch
5. Joint driveways or walkways, joint garages, party walls or rights or support, steps or roofs used in common joint garages:  
see sketch

6. Apparent encroachments. If the building, projections or cornices thereof, or signs affixed thereto, fences or other indications of occupancy appear to encroach upon or overhang adjoining property, or the like appear to encroach upon or overhang inspected premises, specify all such:  
see sketch

7. Specific physical evidence of boundary lines on all sides:  
existing walls and street curbing basis of inspection report
8. Is the property improved? (if structure appears to encroach or appears to violate set back lines, show approximate distance):  
property is improved—see sketch

9. Indications of recent building construction, alterations or repairs:  
none visible
10. Approximate distance of structure from at least two lines must be shown:  
see sketch
