Subject: Supplemental Letter for Phase I Environmental Site Assessment for Tract Z,  
Southwestern Construction. Vinyard & Associates, Inc. Project No.: 11-1-151

*Phase I Environmental Site Assessment for Tract Z*

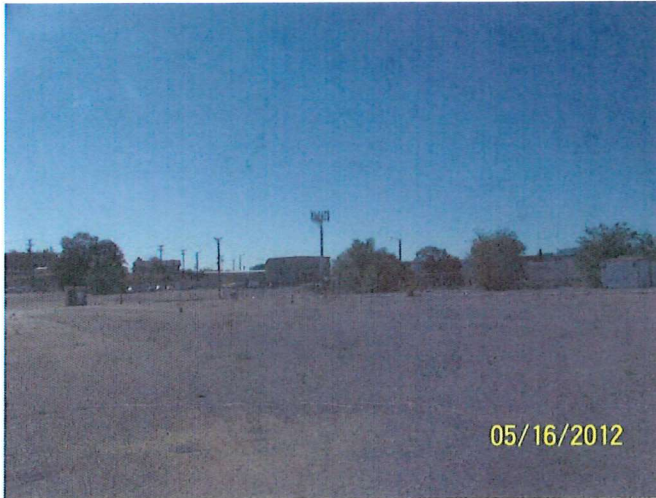
View southeast across the fenced compound.

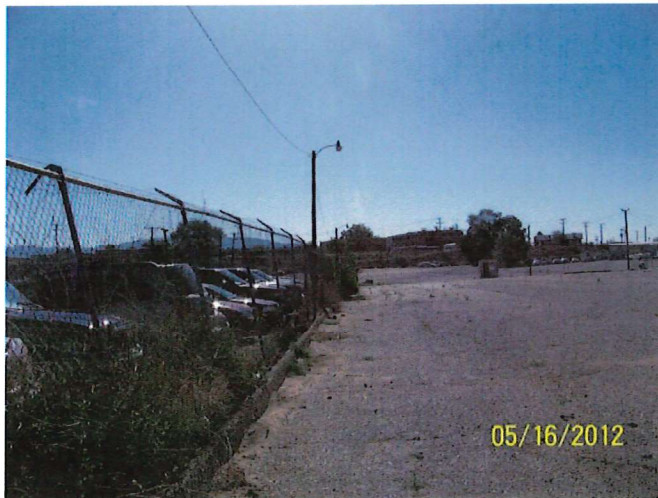
View east along the north side of the fenced compound.

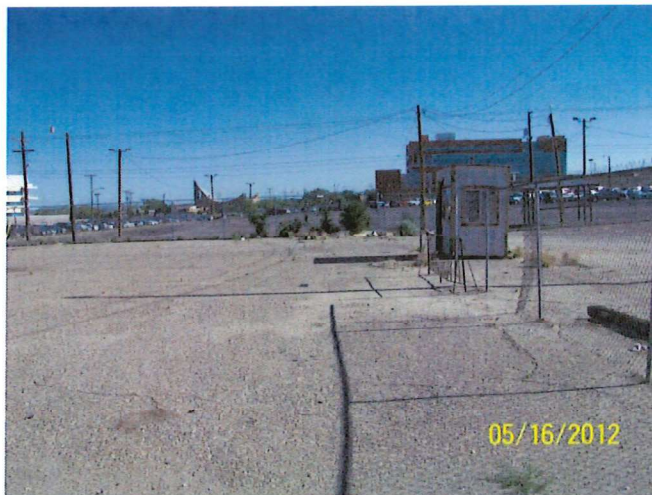
View north along the east side of the fenced compound.

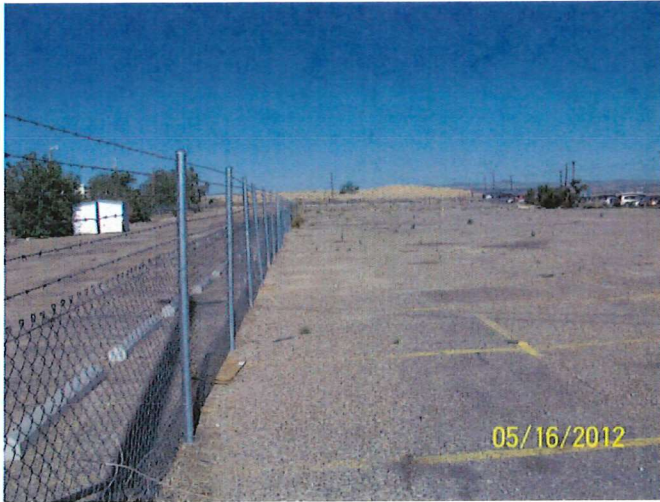
View west along the south side of the fenced compound.

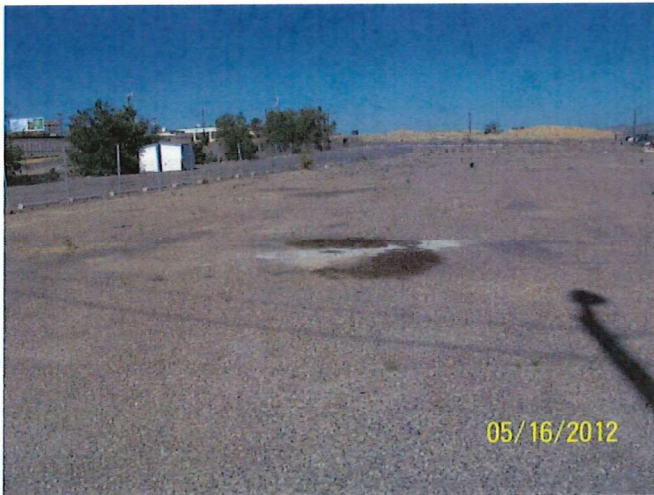
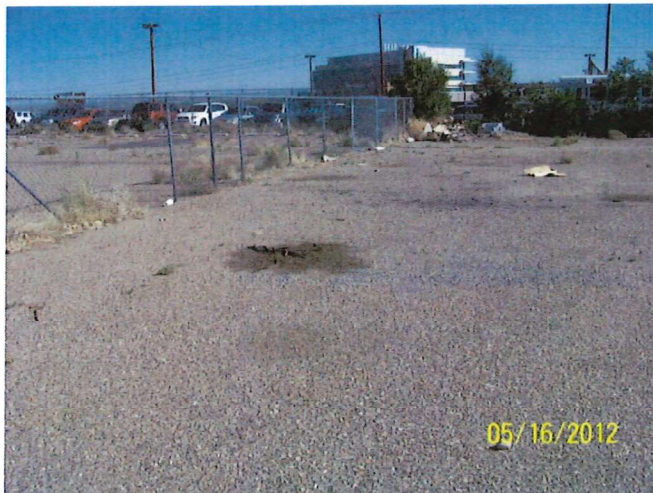
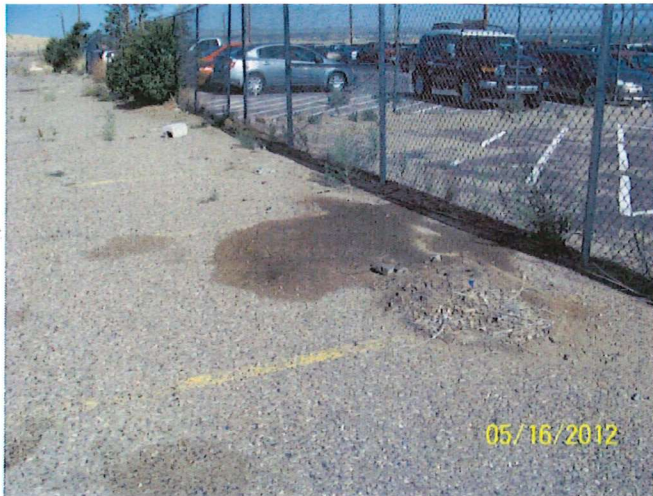
Several areas of surface staining were observed in the parking lot. Some of the oily stains were more than 4 feet in diameter. Since the stained areas are on asphalt, they are not considered to present an environmental concern at this time. Removal and disposal of the oily areas may be considered incidental to redevelopment of the site. If significant areas of stained soil are observed after removal of the asphalt, then additional sampling may be warranted but is not anticipated.

Oily staining on the asphalt inside the fenced compound.

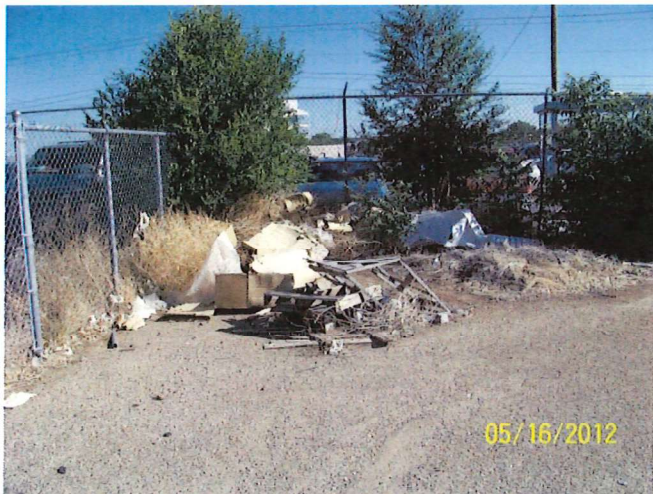
Some surface debris (plastic, wood, brush, cardboard, and tarp, etc.) remained on site, mostly in the northwest and northeast corners of the fenced compound. The surface debris that was observed is not considered to present an environmental concern. Surface debris removal and disposal may be considered incidental to redevelopment of the site.

Surface debris in the northwest corner of the fenced compound.

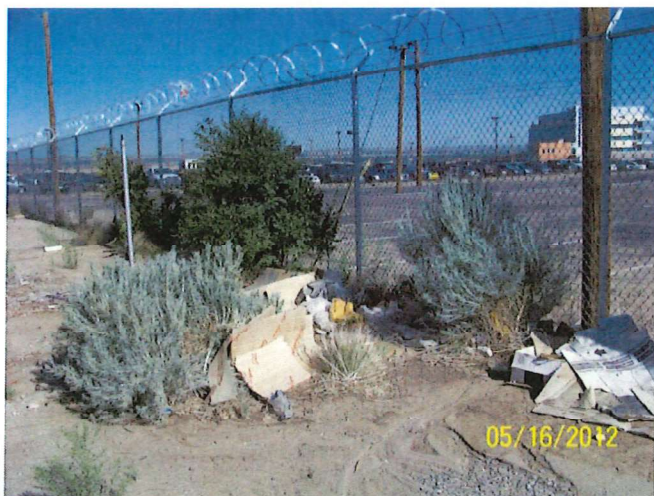
Surface debris in the northeast corner of the fenced compound.
