**Phase I Environmental Site  
Assessment Final Report**  
for the  
**Galles Chevrolet Car Storage Lot**  
Albuquerque, New Mexico

July 10, 1998

Project No. 9849.31 F

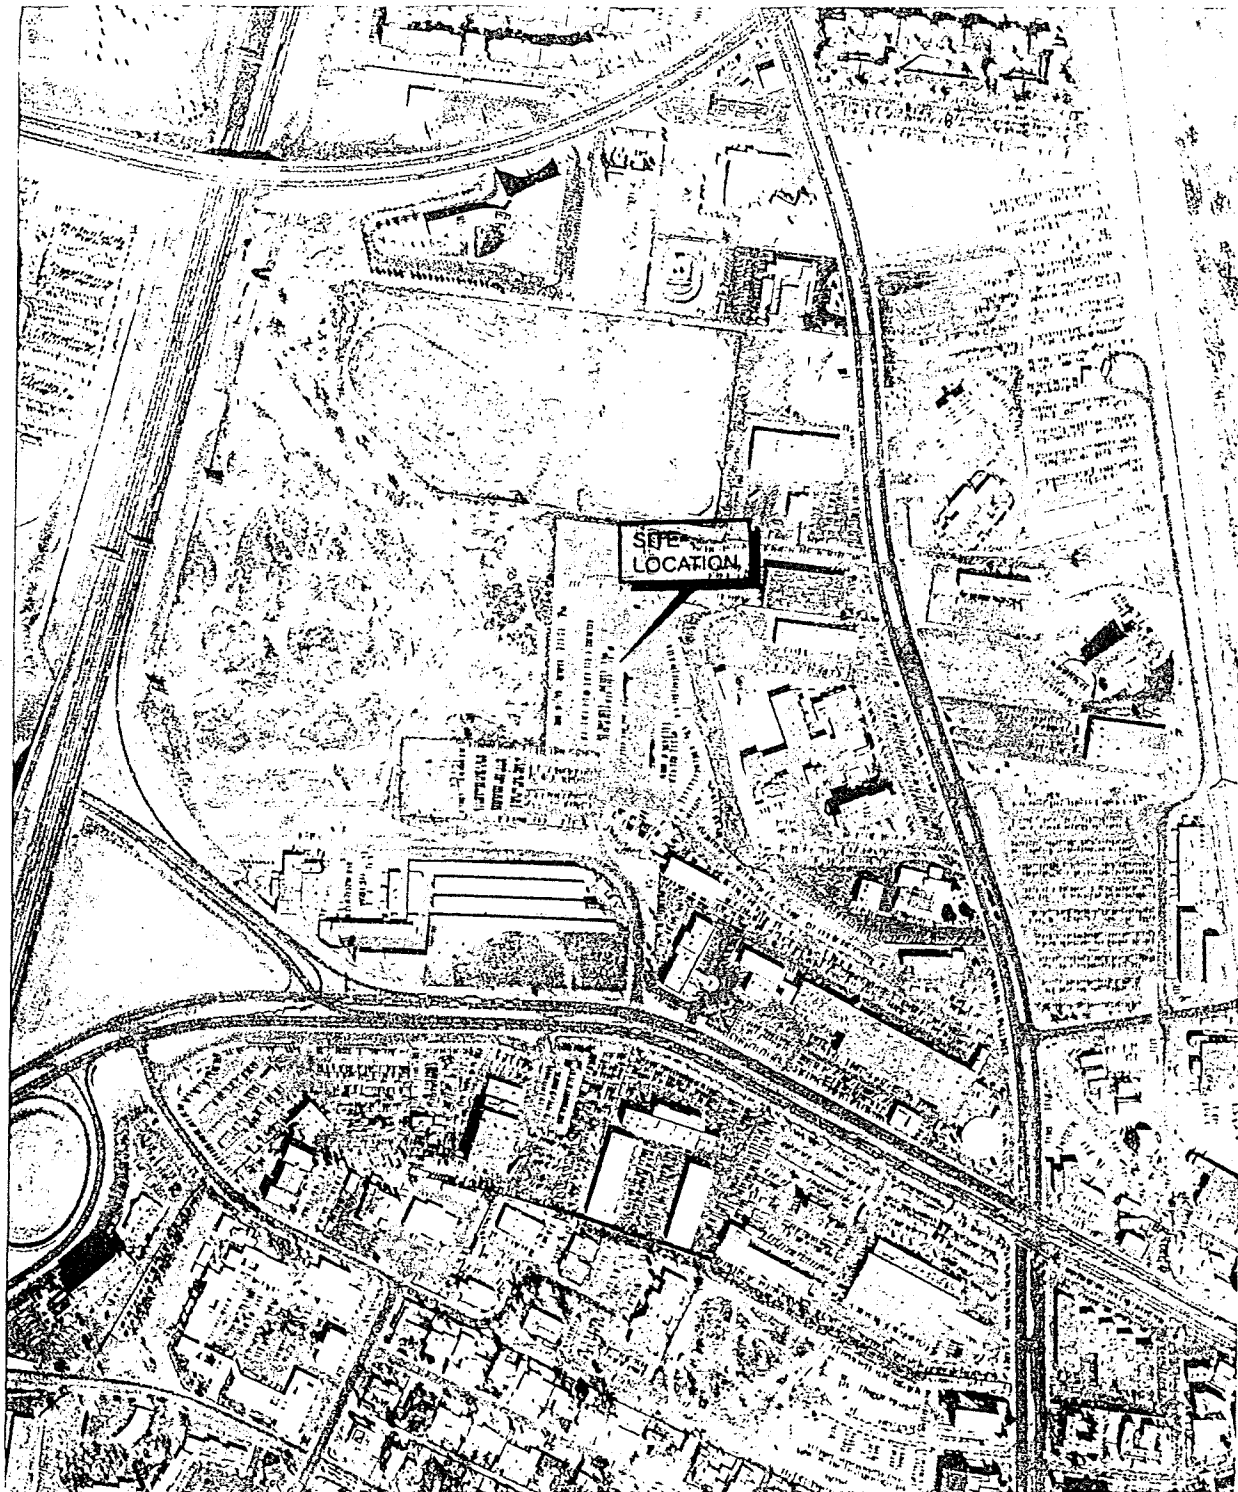
1994 Aerial Photograph

The **1994** aerial photograph depicts the subject site and the adjacent properties as they were noted during the on-site inspection.

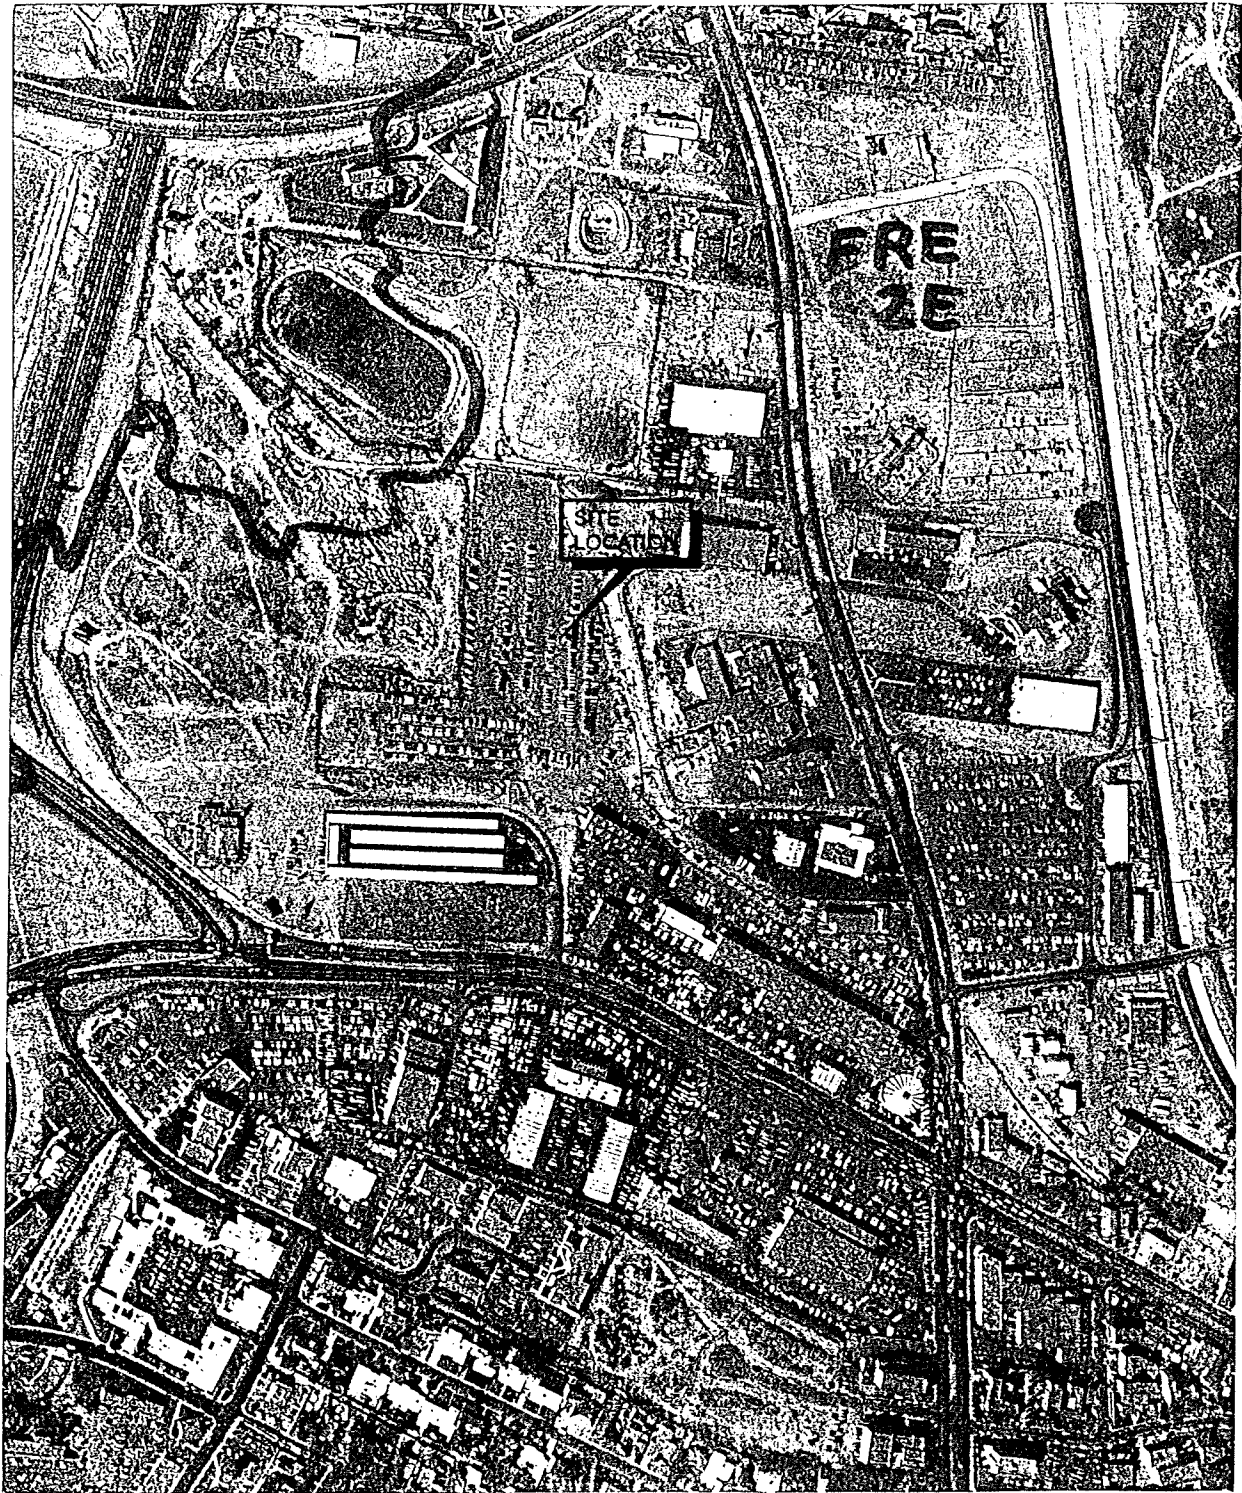
1985 Aerial Photograph

The **1985** aerial photograph depicts the subject site and the adjacent properties as they were noted at the time of the on-site inspection. The adjacent property located to the east of the subject site appeared to be development in this photograph.

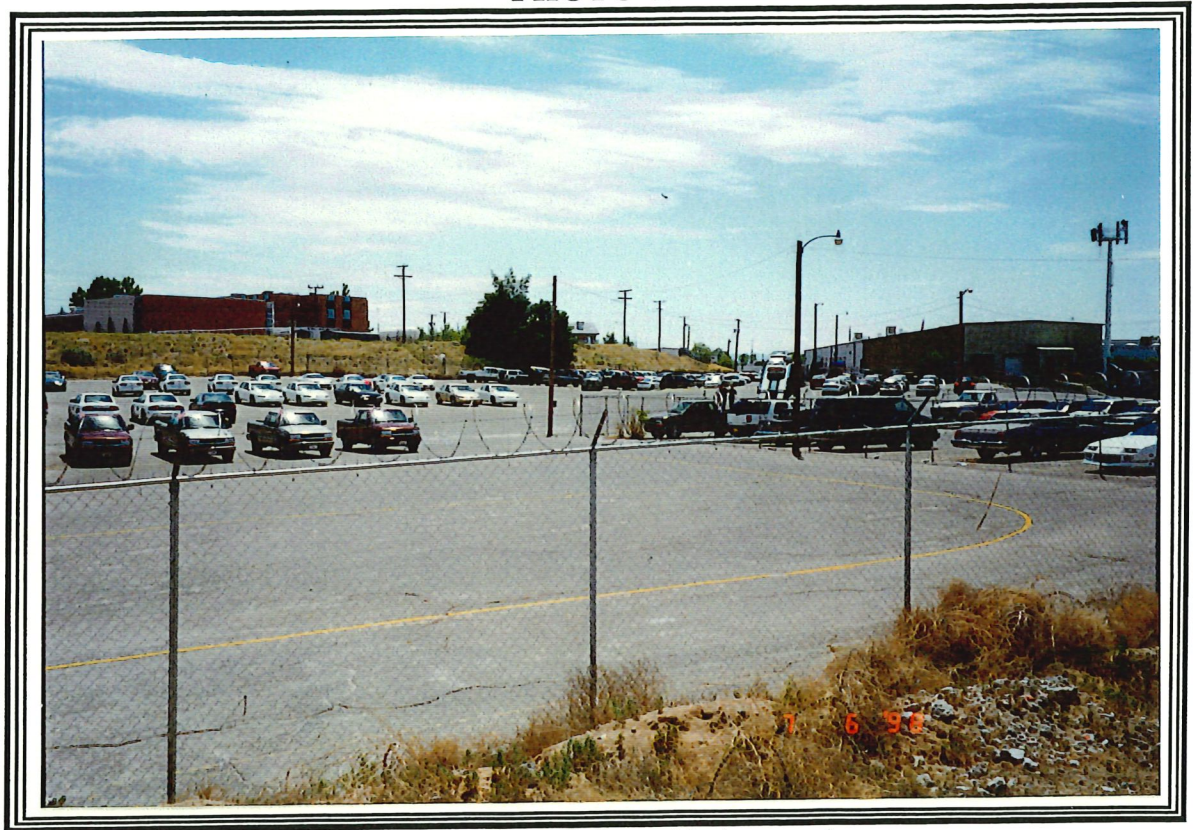
**PHOTO 1**

**Southeastern view of the subject property.**

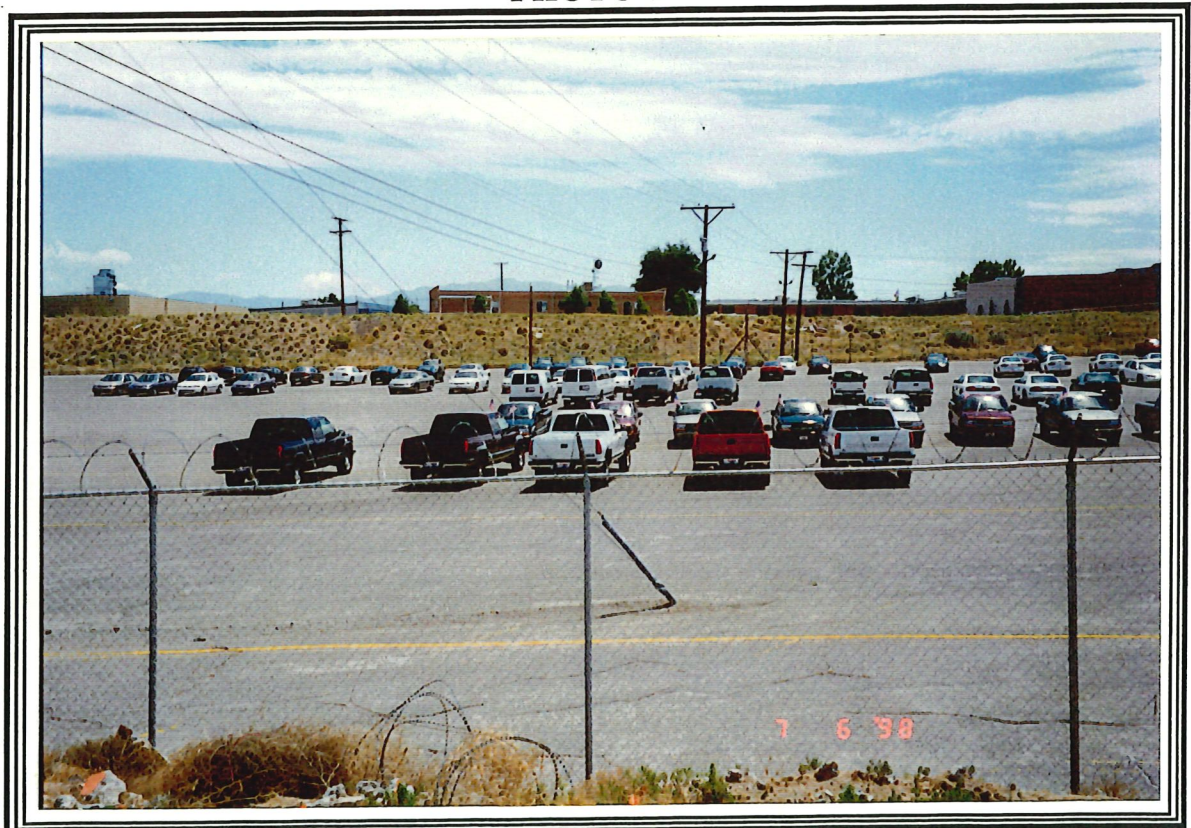
**PHOTO 2**

**Eastern view of the subject property.**

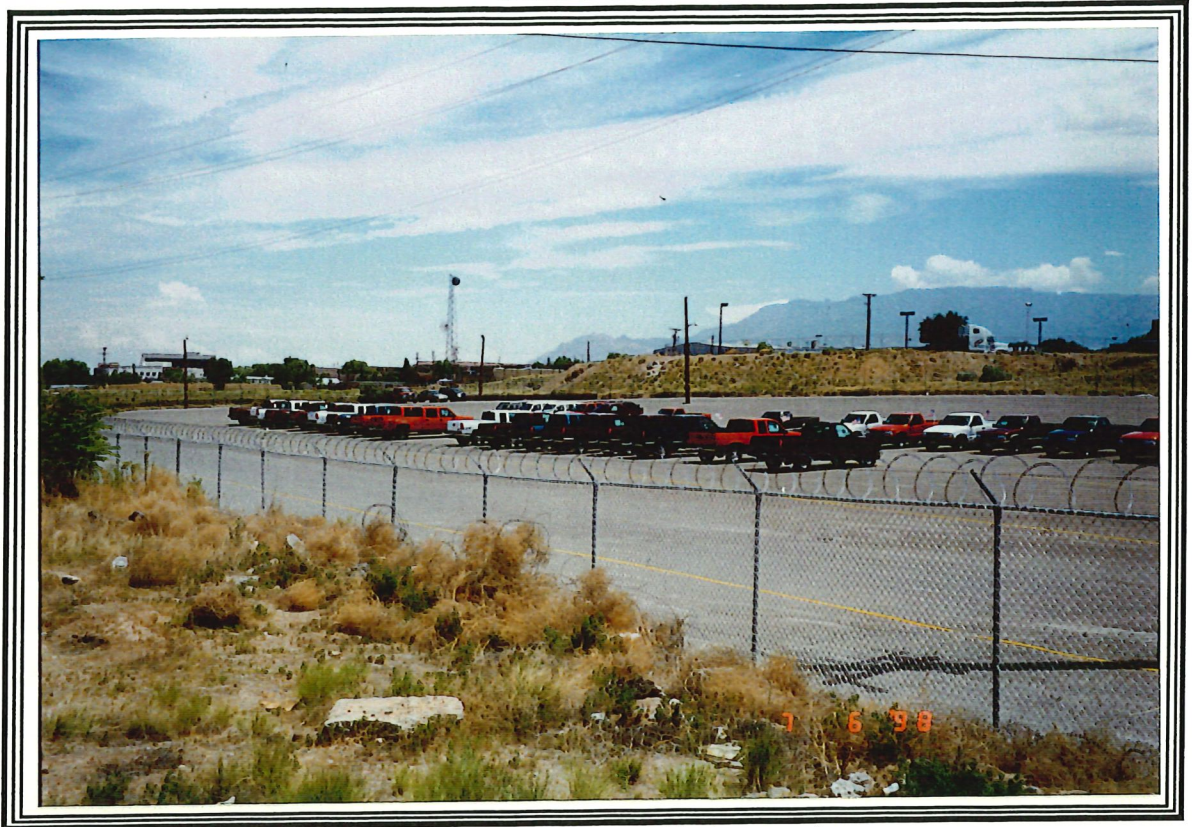
**PHOTO 3**

**Northeastern view of the subject property.**

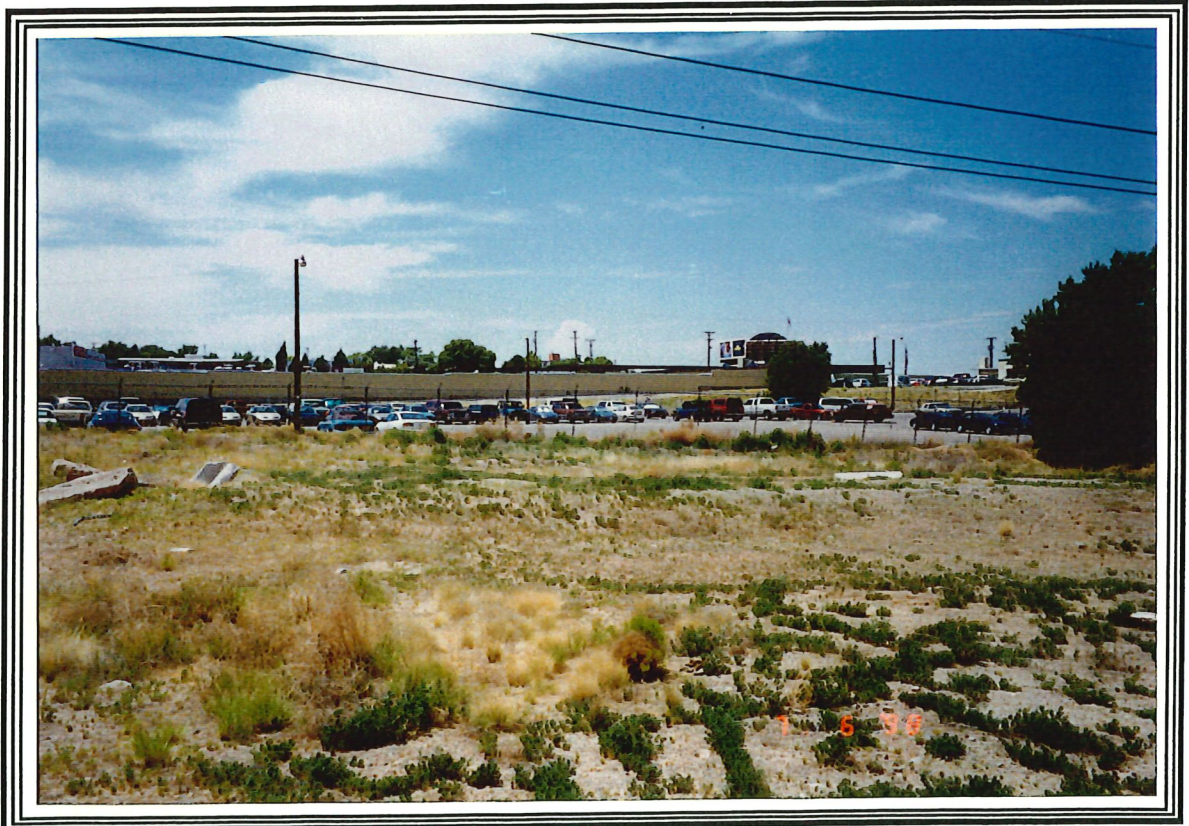
**PHOTO 4**

**Adjacent property to the southwest of the subject site (Saturn of Albuquerque).**

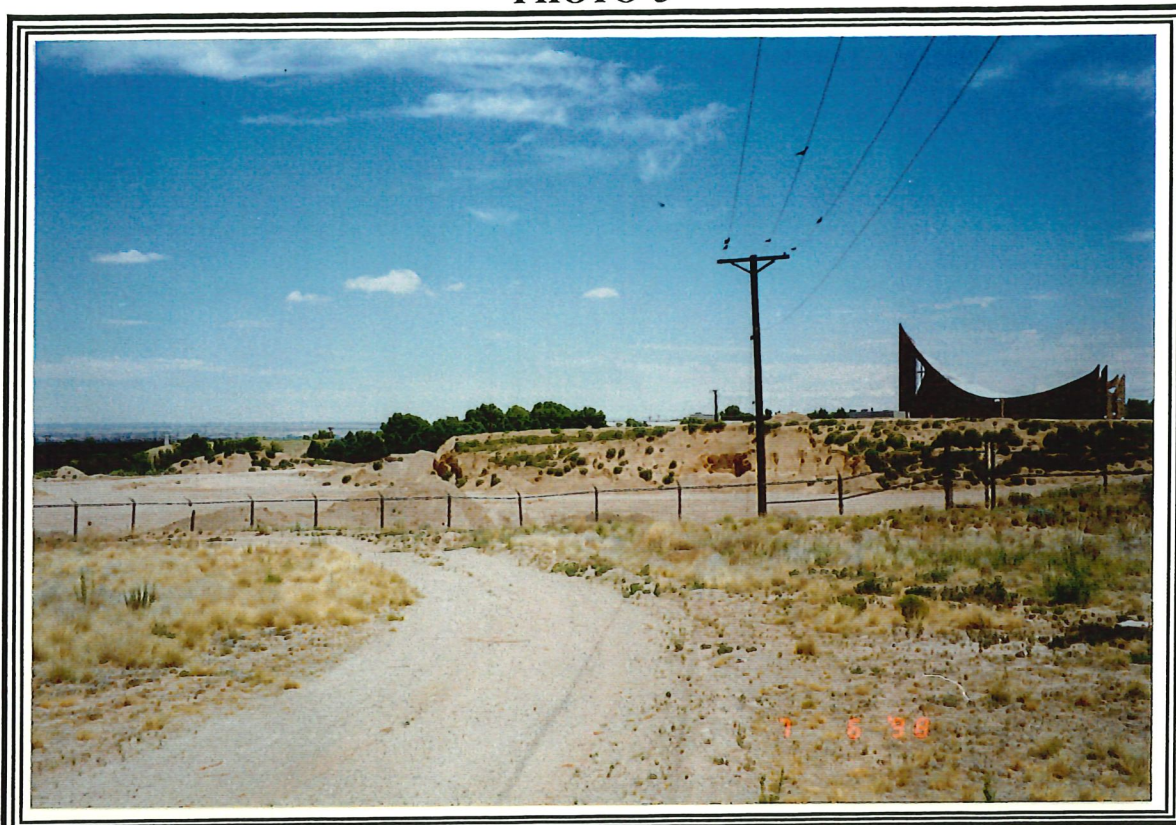
**PHOTO 5**

**Adjacent property to the northwest of the subject site (Vacant Undeveloped Land).**

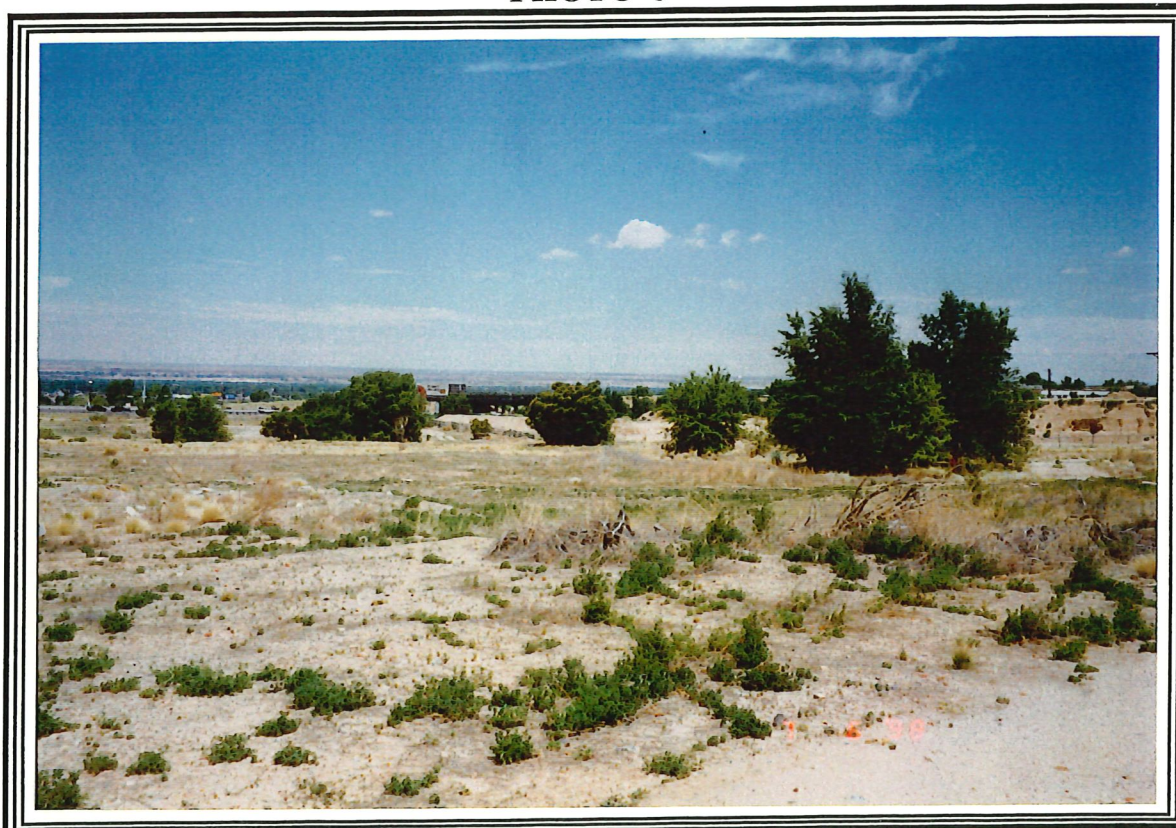
**PHOTO 6**

**Adjacent property to the west of the subject site (Vacant Undeveloped Land).**

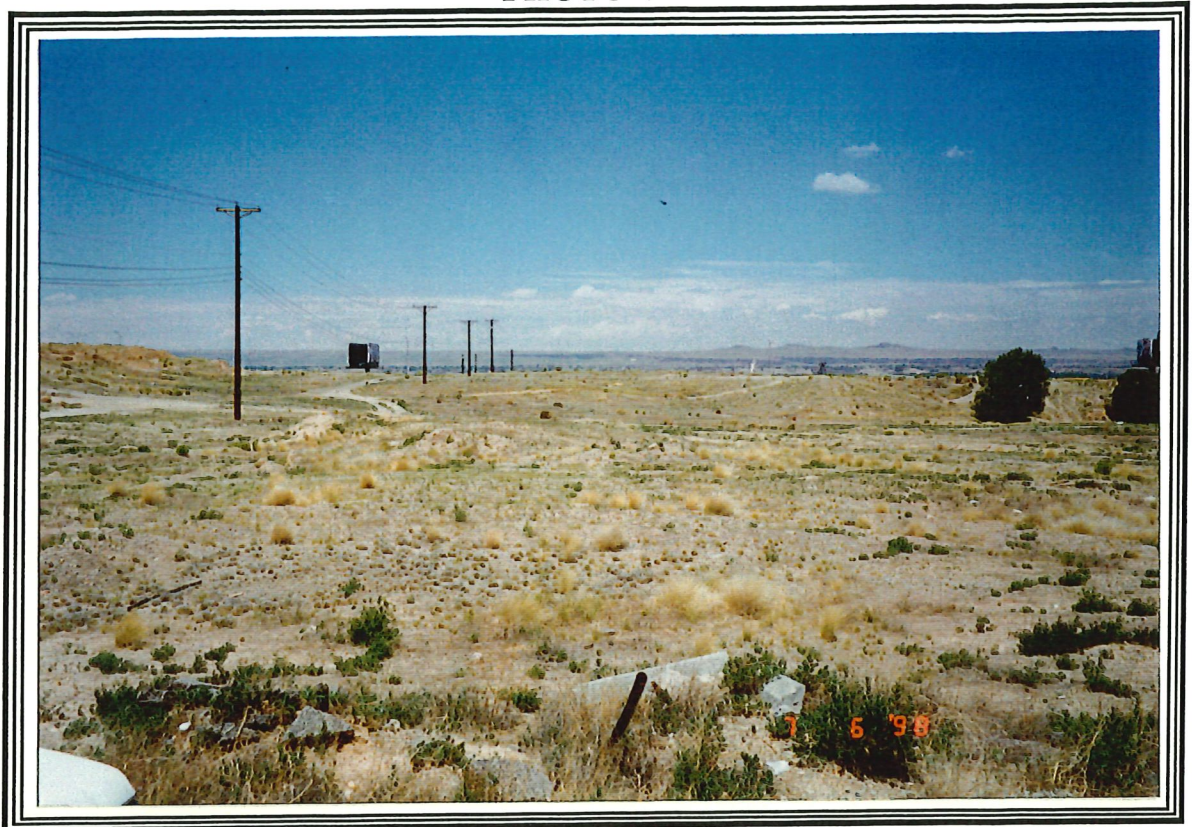
**PHOTO 7**

Adjacent property to the southwest of the subject site (Vacant Undeveloped Land).

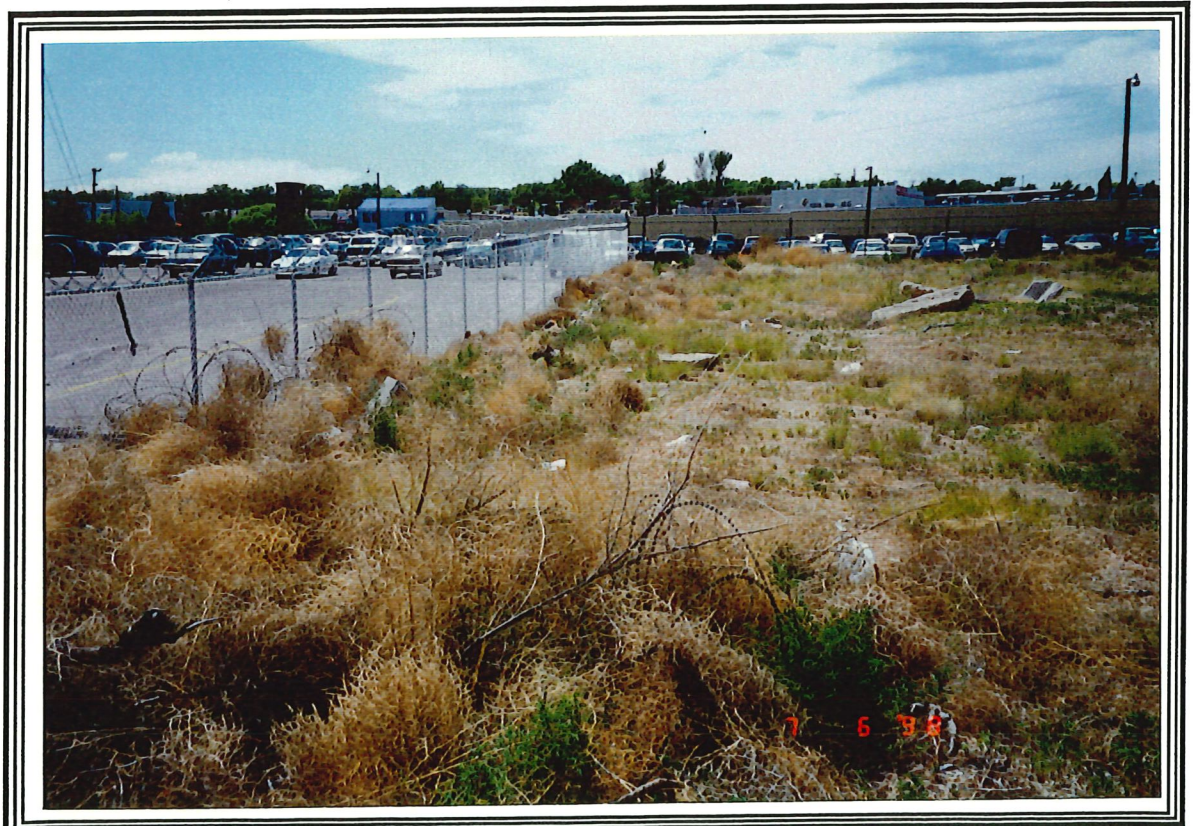
**PHOTO 8**

Solid waste debris to the southwest of the subject property.

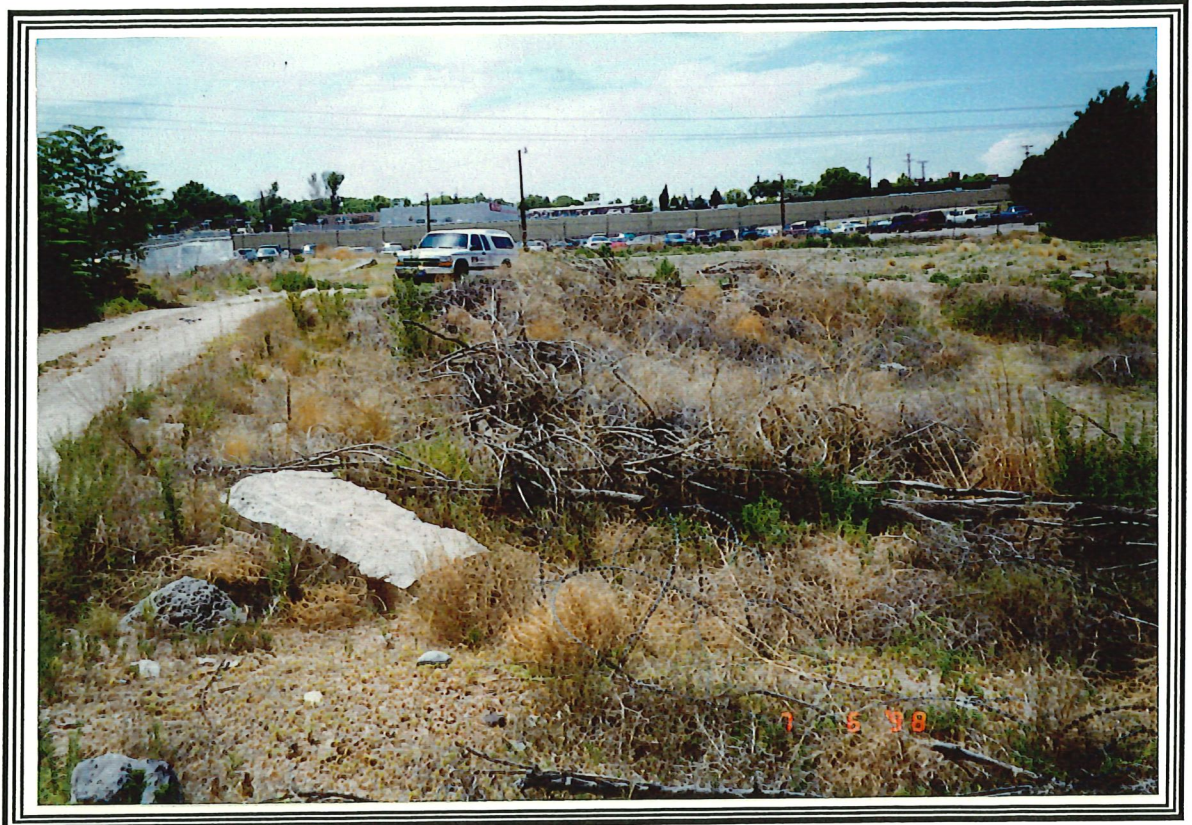
**PHOTO 9**

**Solid waste debris to the west of the subject property.**
