May 18, 2001

**RE:** Hazardous Materials Building Inspection, Laboratory Analysis, and Summary Final Report for the **Elks Lodge Building**, 1642 University Blvd. NE, University of New Mexico, Albuquerque, New Mexico

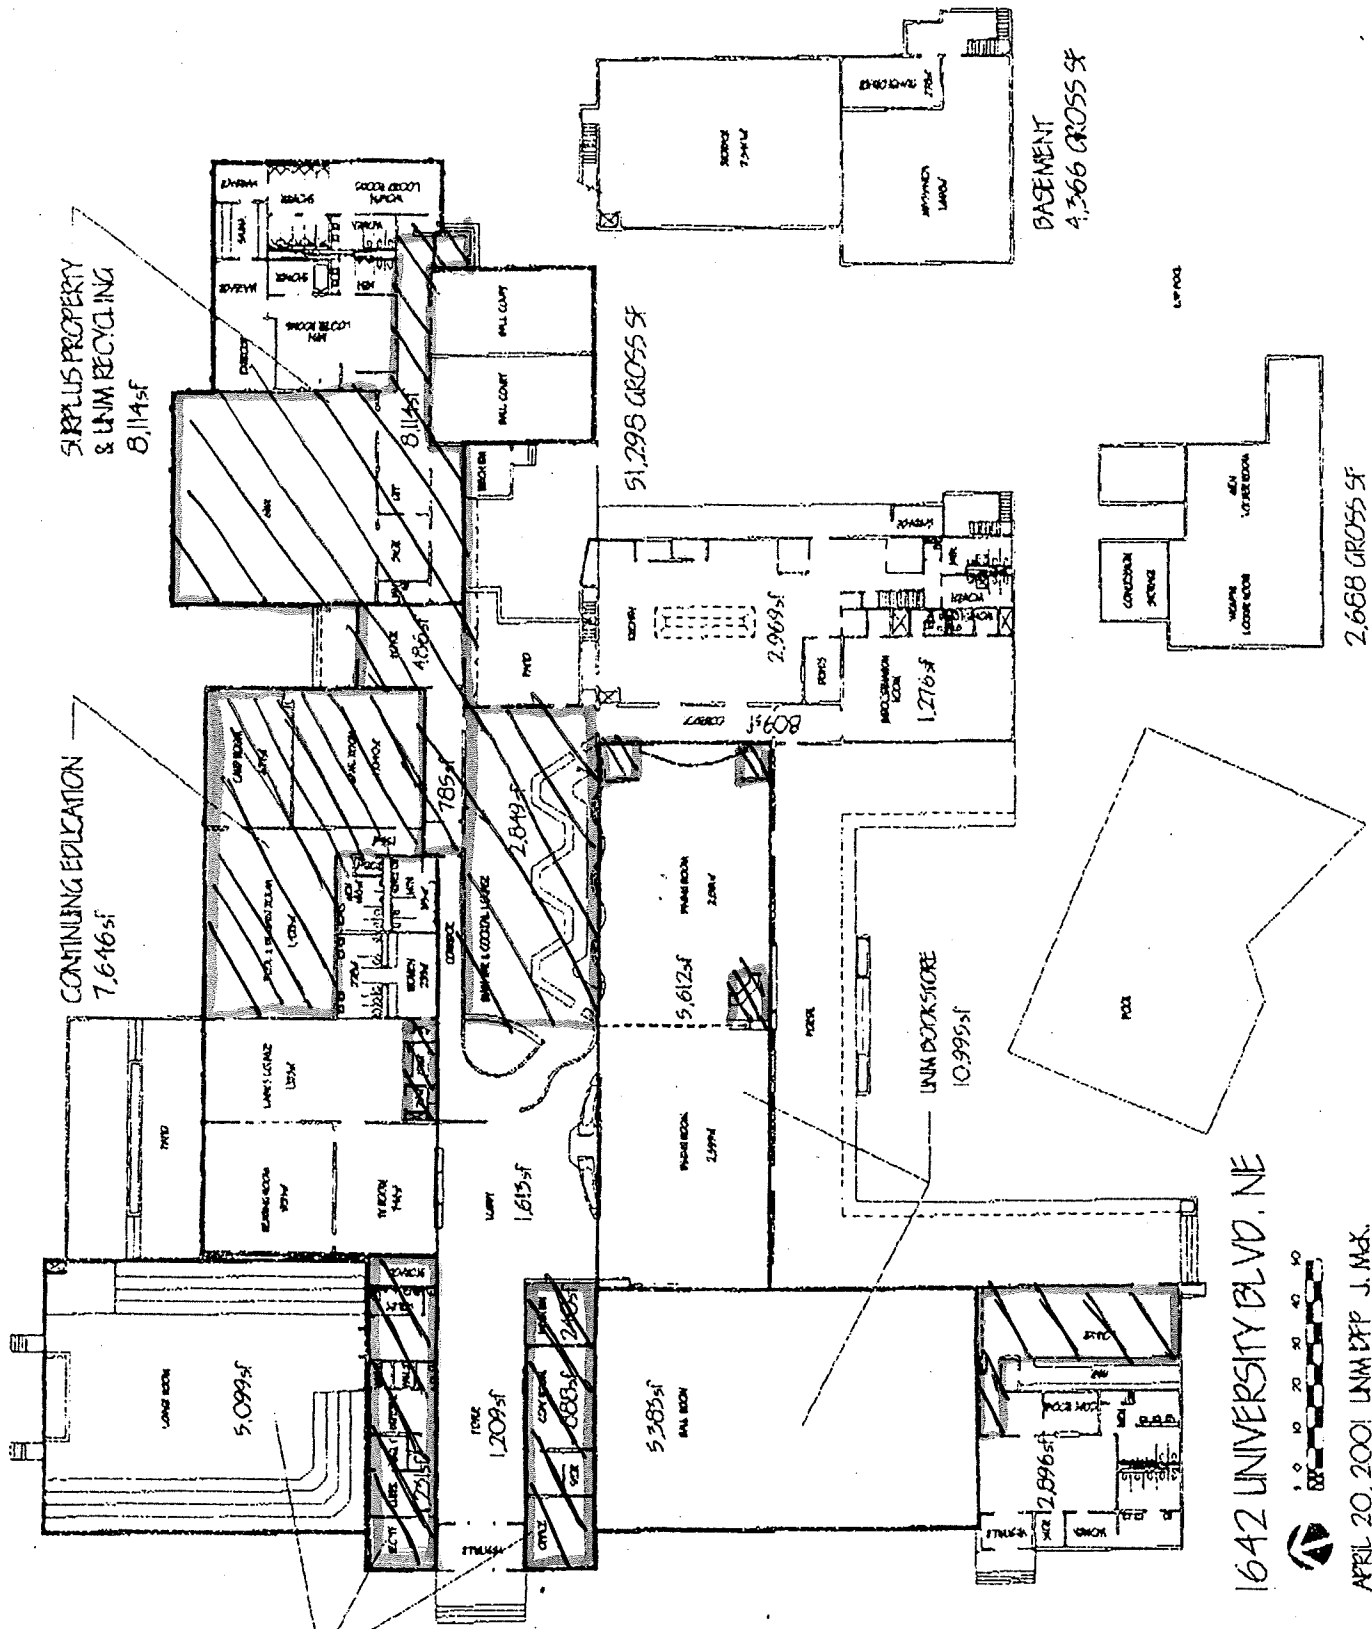
1642 UNIVERSITY BLVD, NE

FLOOR TILES  
 ▨ - with mastic
