PHASE I ENVIRONMENTAL SITE ASSESSMENT

5.7 Acres of Vacant Land
SWC of 98th Street and Gibson Boulevard
Albuquerque, New Mexico

WT Reference No. 3283JE010

Havona Environmental
P.O. Box 35848
Albuquerque, New Mexico 87176

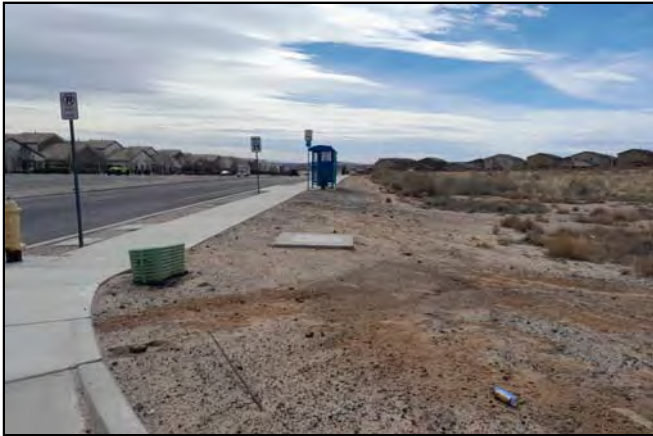
Picture 1 – View from northeast corner facing south. A fire hydrant was located among telecommunication and traffic signal utility boxes.

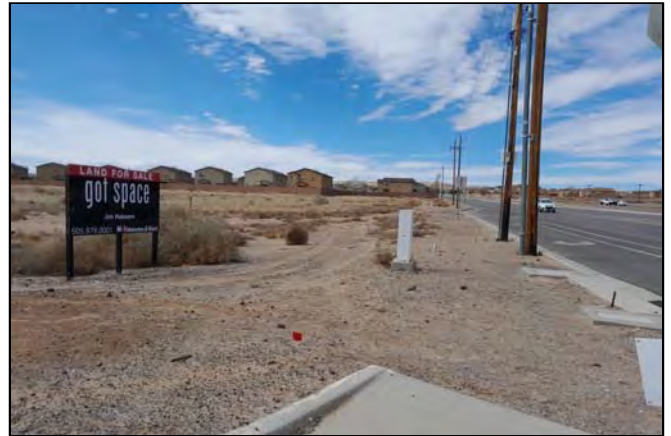
Picture 2 – View from northeast corner facing west. Markers for buried electric cables were located alongside fiber optic traffic utility boxes.

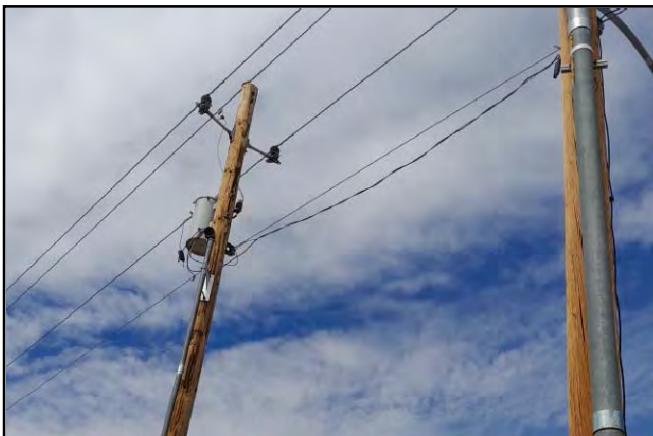
One pole-mounted transformer on the northeast corner appeared to be in good condition and did not exhibit signs of corrosion of the metal exteriors, leakage, oily residues, or oily staining on the ground surface. Based on the age and the observed condition of the unit, it does not represent a REC in connection with the Subject Property.

Picture 3 – Pole-mounted transformer at Property's northeast corner. Overhead powerlines were located along the northern Property boundary.

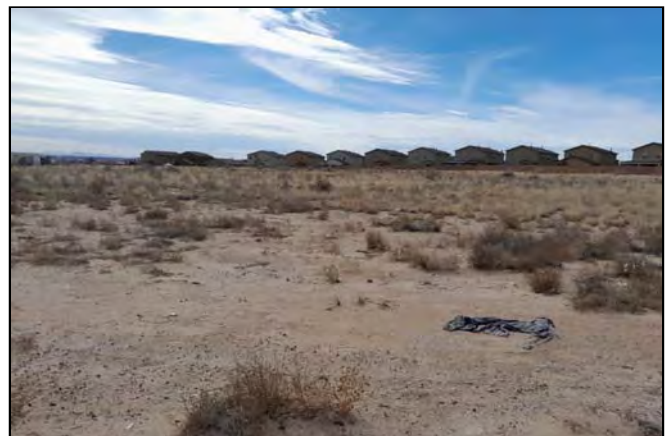
Picture 4 – View across Property from northern boundary, facing south. An unimproved road was present along the northern Property boundary.

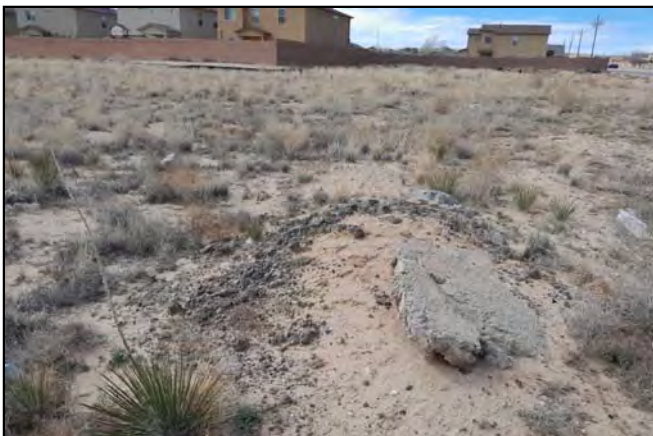
Picture 5 – Small pile of asphalt and cement rubble near the center of the Property's northern boundary.

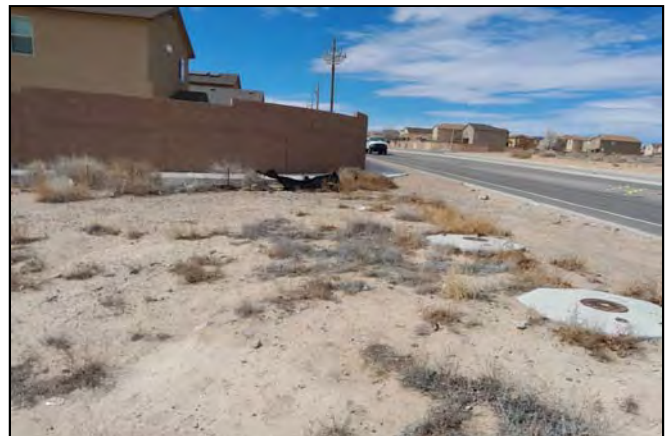
Picture 6 – View of the Property's northwest corner including two water mains, sidewalk, and silt fencing.

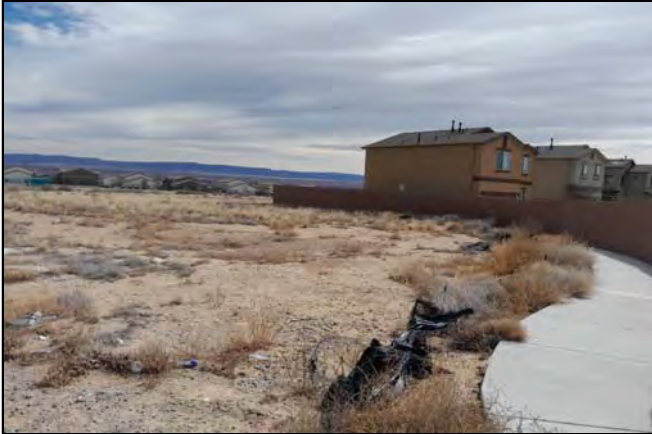
Picture 7 – View from Property's northwest corner, including a short segment of sidewalk, windblown litter, and collapsed silt fencing.

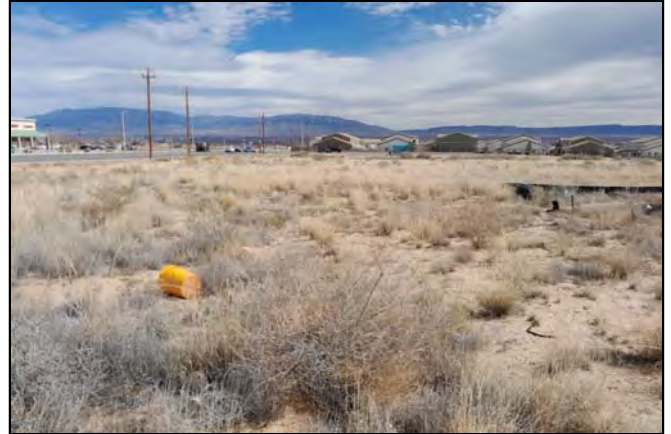
Picture 8 – View across Property from inner northwest corner, facing east. An empty yellow pail was observed among other windblown litter.

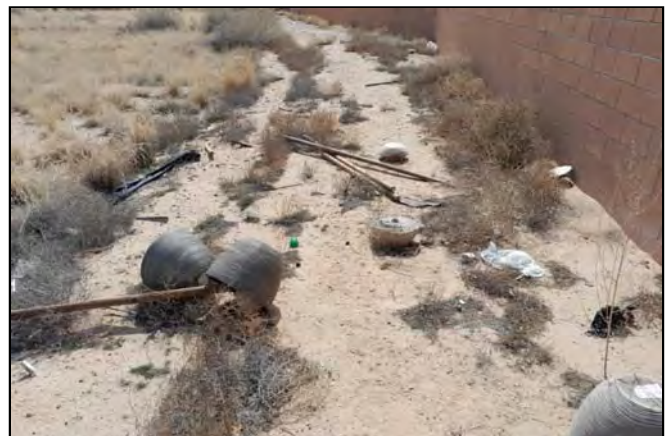
WT observed occasional windblown litter and light residential landscaping debris on the Subject Property. Plastic flowerpots, wooden posts, plywood, and plant trimmings were observed along the cinderblock wall at the Subject Property's southwest boundary. A small mound appearing to contain concrete and asphalt rubble was observed near the center of the Subject Property's northern boundary. The surface-placed debris does not represent a REC in connection with the Subject Property given the types of material observed.

Picture 10 – Discarded items, likely originating from adjacent houses, was observed near the wall of the Property's curved southwest boundary.

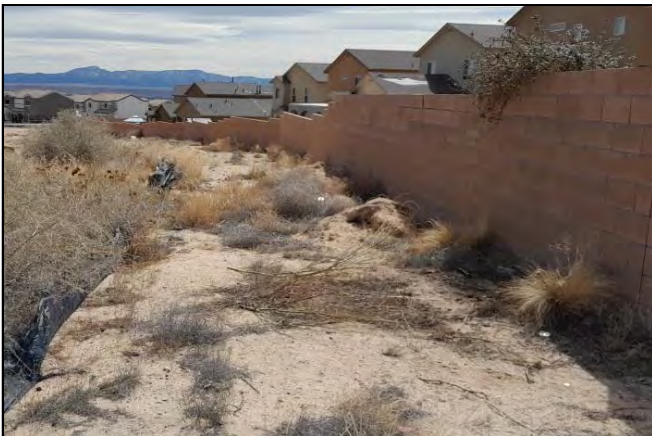
Picture 11 – Vegetation trimmings likely from the adjacent houses along Property's southwest boundary.

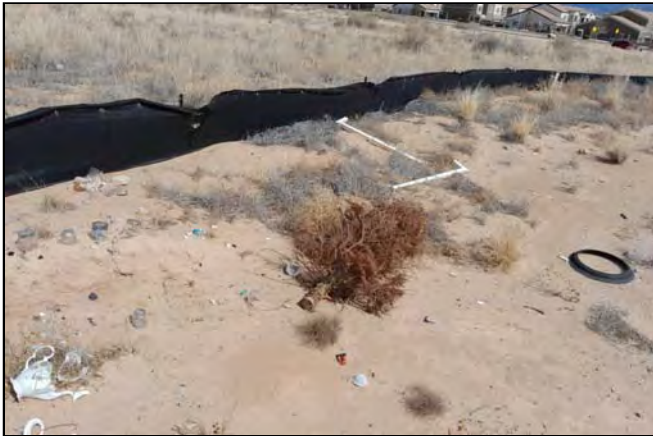
Picture 13 – Short sections of pipe and material approximately 290 feet northwest of the Property's southeast corner.

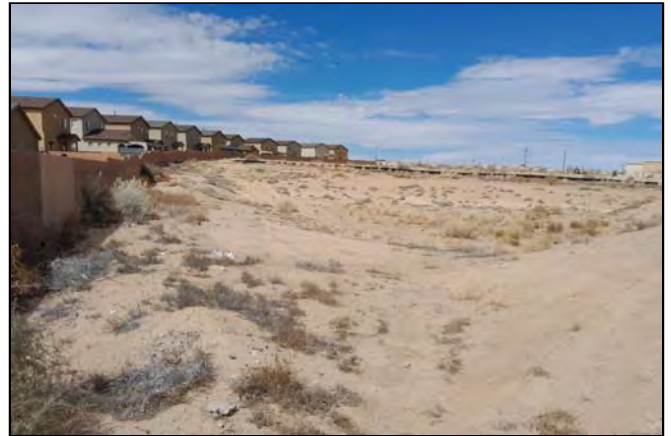
A retention pond on the southeast corner of the Subject Property did not exhibit signs of staining, corrosion, discoloration, or noxious odors; therefore, this retention pond does not represent a REC.

Picture 14 – A stormwater retention area located near the Property's southeast corner. View facing northwest.

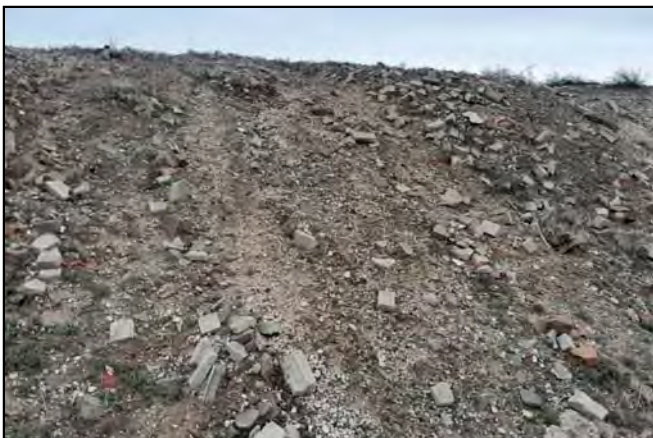
WT interviewed James Dyer, Hydrologist with the NMED Solid Waste Bureau, by phone on March 23, 2023. Mr. Dyer did not recognize the reported solid waste disposal area to the north and northeast of the Subject Property as an historical landfill known to NMED and he noted that illegal dumping in arroyos on the westside of Albuquerque is common. Based on our interview, Mr. Dyer believed the solid waste disposal area represented an Illegal dump site.

Picture 17 – Remnants of the historic illegal dumping site to the north of the Property on vacant land northwest of the Walgreens pharmacy.

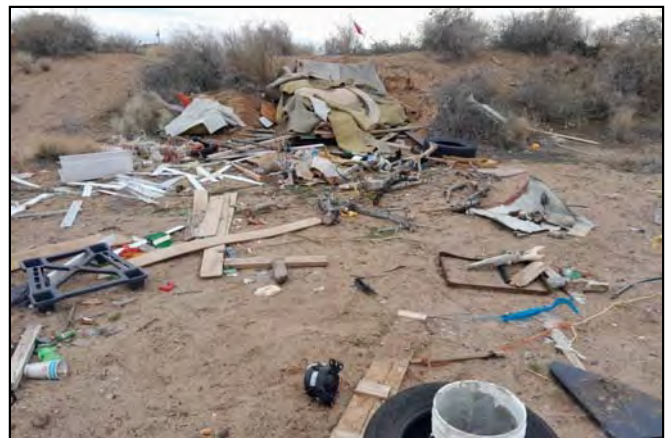
Picture 18 – Recent illegal dumping at the dumping site to the north of the Property.
