APPRAISAL REPORT

A Single Family Residence Located At

**1705 Las Lomas Road NE
Albuquerque, New Mexico 87106
MSA # 0200
Homeowner: Anthony Cardenas**

July 19, 1996

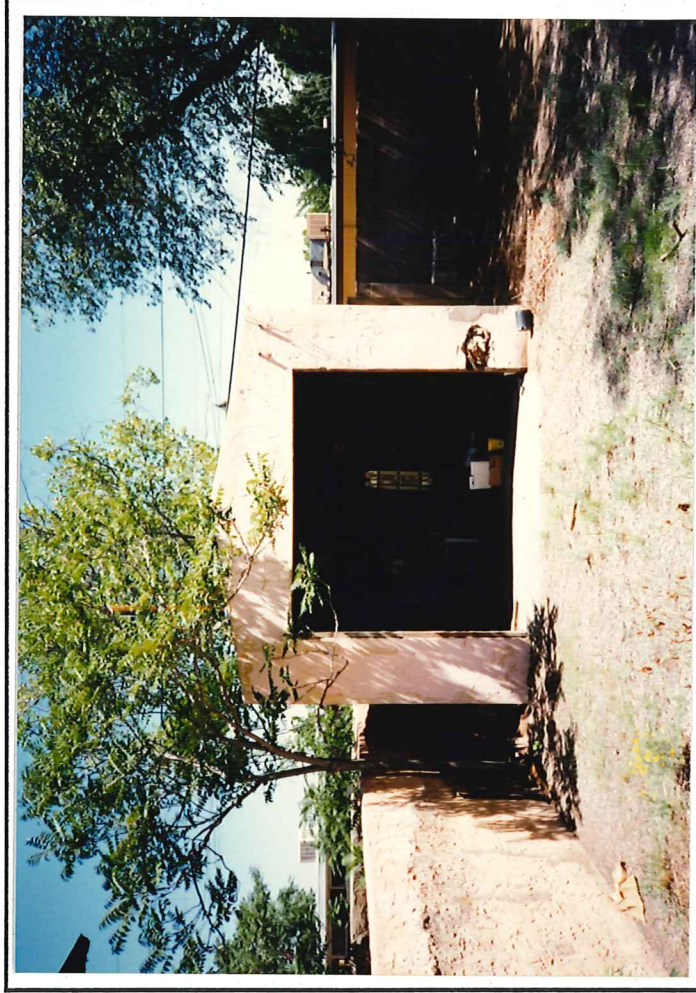
There is a 12.1' x 18.5' (224 square feet (rounded) detached one car garage. It is constructed of stucco over wood frame with a flat roof and tar and gravel covering. The interior is exposed framing. It does not have a car entry door. The front is open.

The condition of the one car garage is fair. It needs new exterior stucco and an overhead door installed.

VIEW OF THE
DETACHED ONE CAR
GARAGE.
