APPRAISAL REPORT

A Single Family Residence Located At

**1713 Las Lomas Road NE
Albuquerque, New Mexico 87106
MSA # 0200**

**A Complete Appraisal, Communicated Through a Summary Report
(See Page 2, Addendum A)**

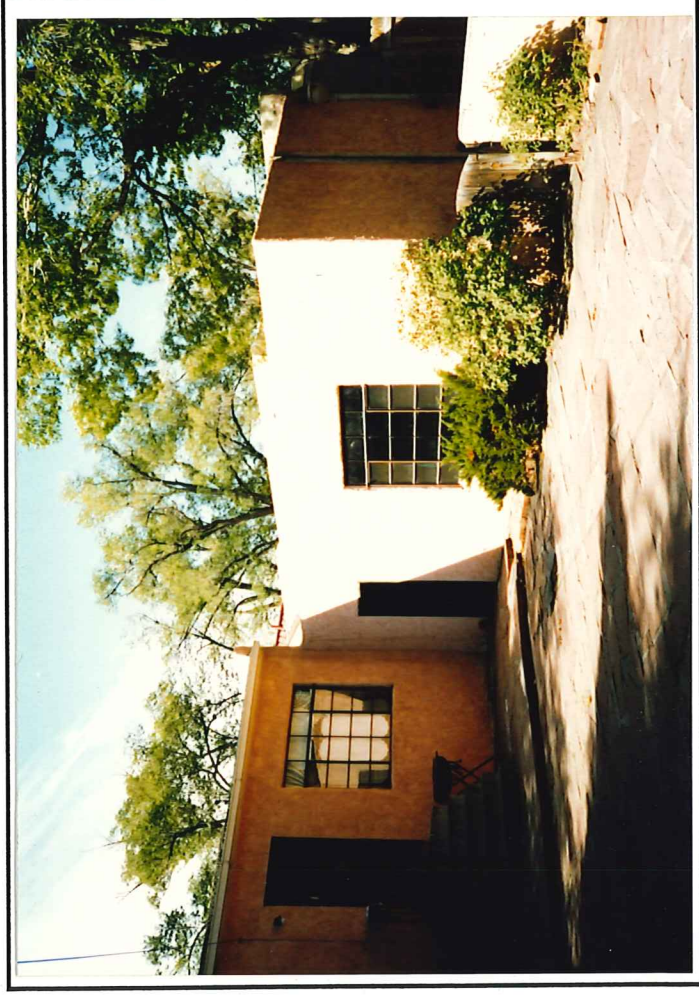
REAR

There is a 287 square foot storage building constructed of stucco over adobe which is attached to the rear of the one car garage.

Additionally, the 287 square foot storage building attached to the rear of the one car garage is in fair to poor physical condition and is depreciated at 100% of its cost as it serves no useful purpose and the market will pay no extra for this amenity.

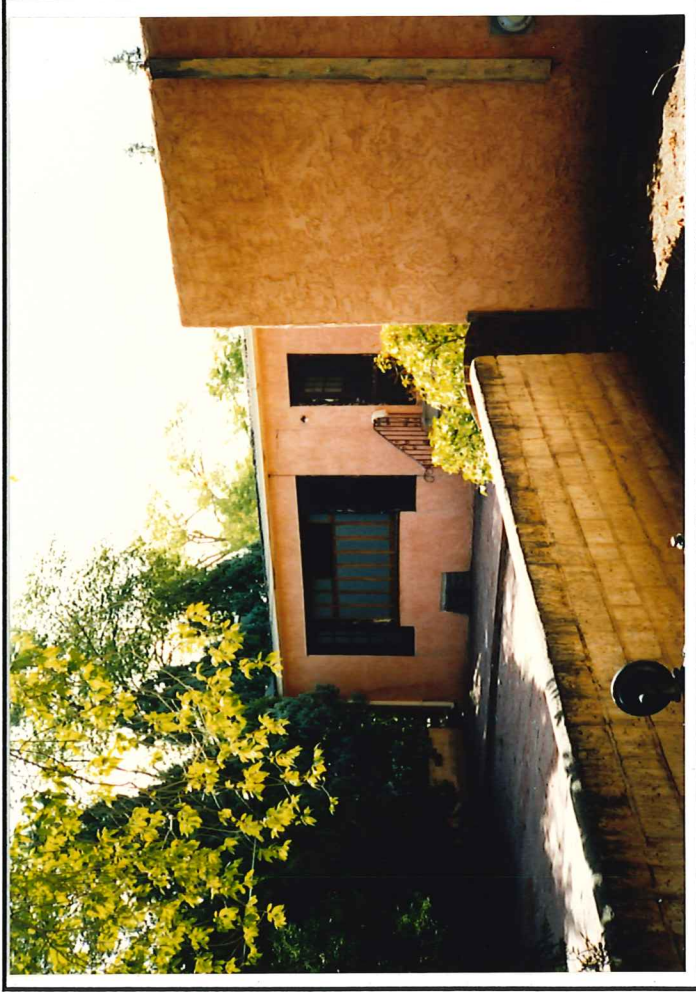
Additional view of
the rear of the
subject.
