**PHASE I
ENVIRONMENTAL SITE ASSESSMENT
TRACT Z
1201 UNIVERSITY BOULEVARD NE
ALBUQUERQUE, NEW MEXICO**

Project No.: 11-1-151

November 15, 2011

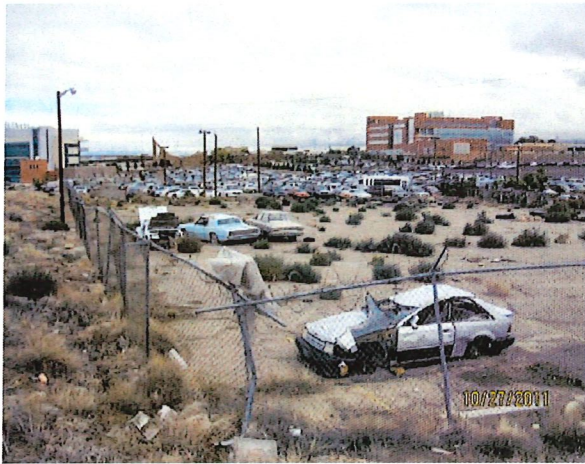
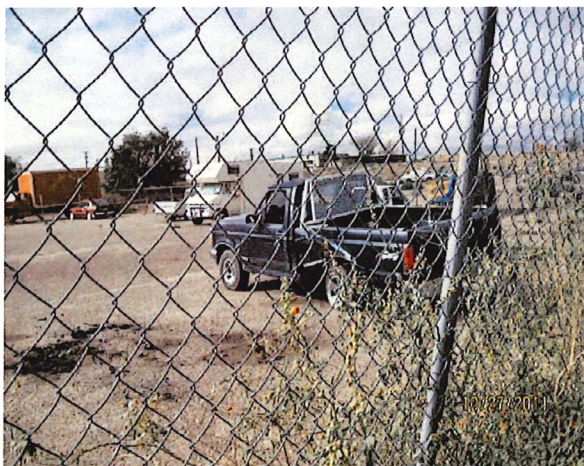
Figure 10

- The abandoned parking lot had a variety of abandoned vehicles with varying degrees of damage and none appeared drivable. Additionally, there were dumped tires in the lot and a temporary building that may have been a portable construction office in the parking lot. Vinyard & Associates recommends that these vehicles be removed and appropriately disposed. If significant releases of petroleum products have occurred

Three views of the abandoned parking area at the north end of the developed portion of the site. The abandoned lot is on the north end of the UNMH parking lot

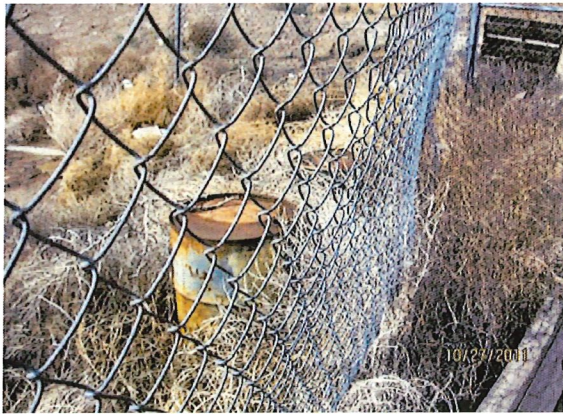
With the exception of the two drums described above and the abandoned vehicles on the developed portion of the property, there were no obvious, visible signs of potential surface sources of contamination noted during the site visit. There were no observable signs of releases from the drums or the vehicles.

View of the two drums located in the northwest corner of the abandoned parking area on the other side of the fence from the southwest corner of the UNMH parking lot.

Based on the information reviewed and the conditions observed during the site visit, it appears that the potential for unknown adverse environmental impacts that may exist on the site is low. Based on the information reviewed, nearby NPL, CERCLIS NFRAP, ROD, RCRA generator, SCS, registered UST, and LUST sites appear to present a limited environmental hazard relative to the subject site. This assessment has revealed one Recognized Environmental Condition (REC) in connection with the property. There are two abandoned 55-gallon drums located in the northwest corner of the abandoned parking lot at the southern end of the UNMH parking lot. The drums could not be accessed to establish whether or not they were empty and whether or not releases had occurred. Vinyard & Associates recommends that the two drums be removed and properly disposed by a permitted hazardous waste disposal company. Vinyard & Associates also recommends that soil sampling be conducted if there is evidence of releases from the drums to establish appropriate contamination remediation measures.

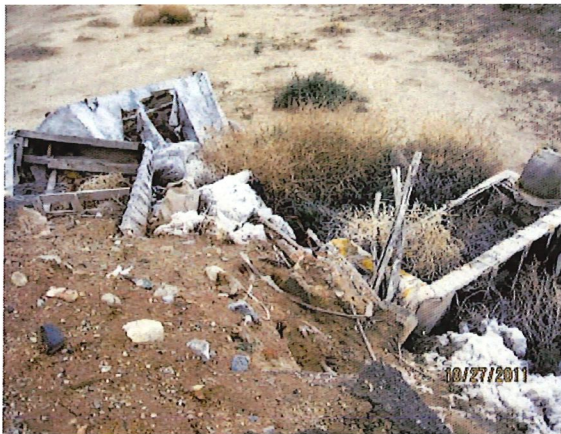
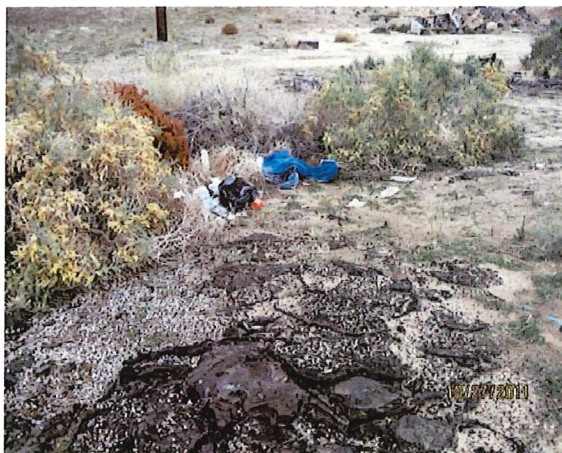
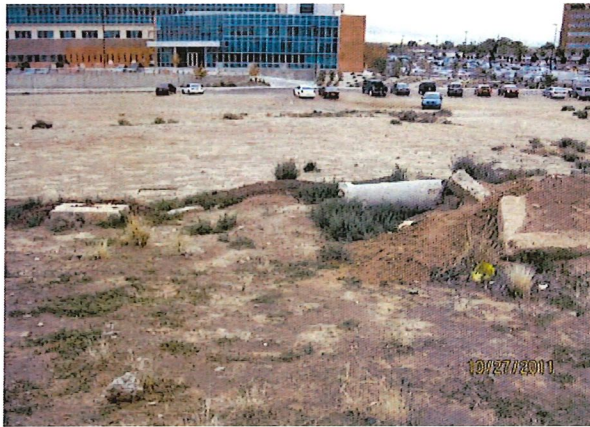
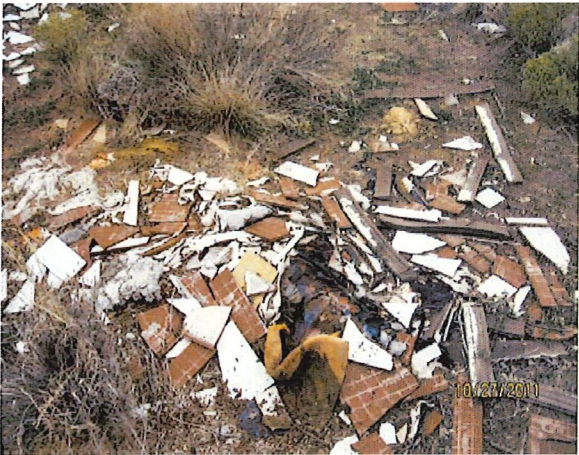
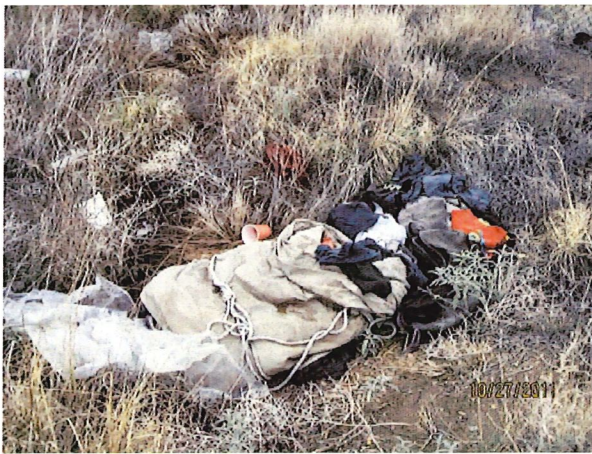
Figure 11

- There are numerous small illegal dump sites scattered on the vacant portion of the site. The dumped materials include construction debris, landscaping debris, and domestic waste such as clothing and furniture. Vinyard & Associates recommends that the dumped material be properly disposed.
- Although there was no observable evidence that the site had been used as a landfill, a substantial amount of earthwork appears to have been performed on the site. There may be buried trash and debris on the site. Vinyard & Associates recommends a thorough geotechnical investigation prior to development of the site.

There were no observable signs of staining or releases from any of the dumped materials on the undeveloped portion of the site. With the exception of a damaged empty five-gallon paint pail there were no other containers observed on the undeveloped portion of the site.

Six views of trash, construction debris, and landscaping debris observed on the undeveloped portion of the site.

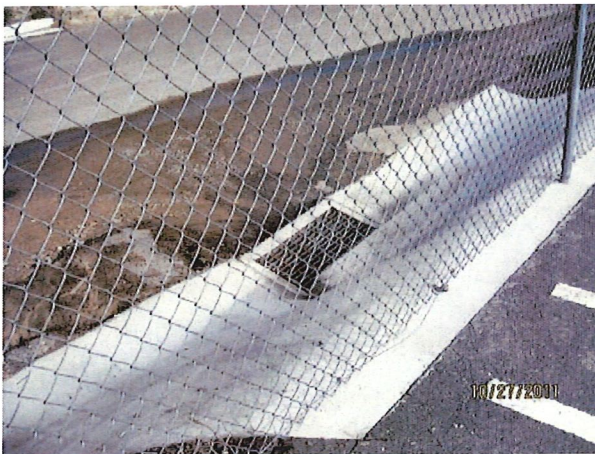
View of the storm drain outside the fence at the northwest corner of the UNMH parking lot on the developed portion of the site.

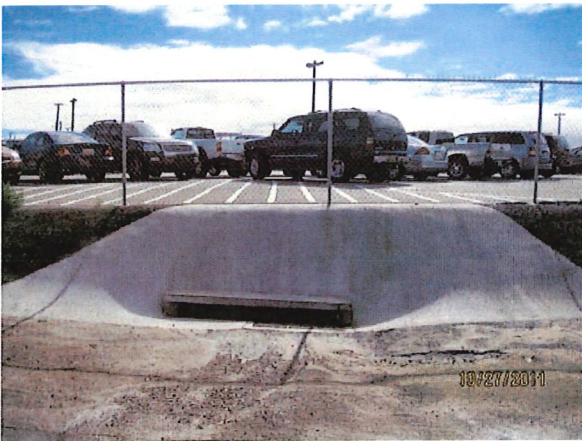
View of the above storm drain from the street.

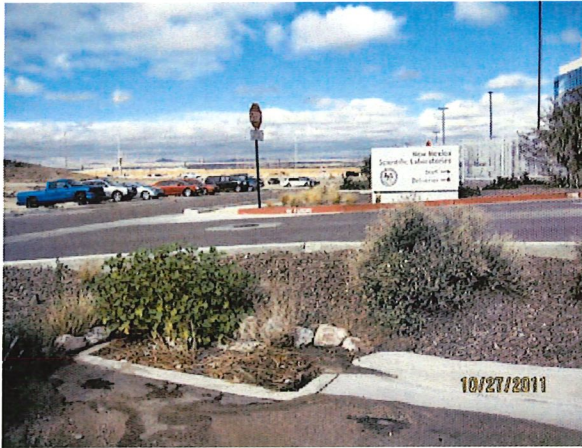
View of the storm drain located on the north side of Camino de Salud. The drain may be on the site.

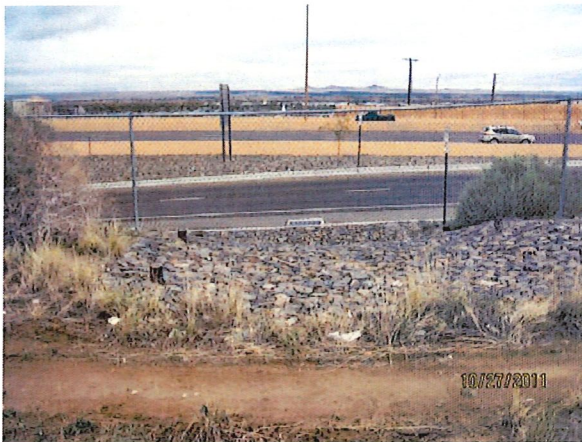
View of the storm drain located on the east side of the freeway frontage road on the west side of the site approximately midway between the northwest and southwest corners of the undeveloped portion of the site. The cobble in the foreground provides erosion control.

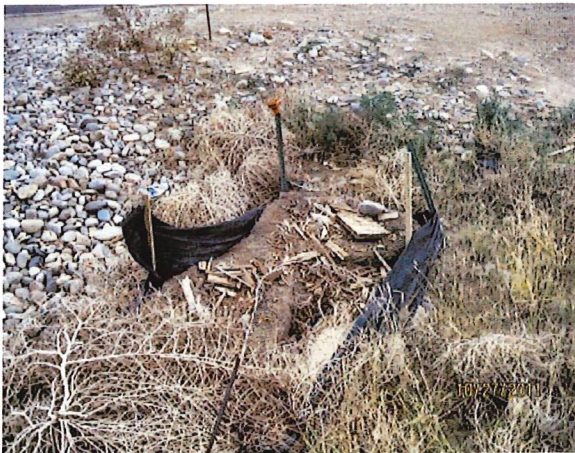
Figure 14

View of a storm drain located in the triangle of land between the northern boundary of the undeveloped portion of the site and Camino de Salud.
