ASBESTOS AND LEAD BASED PAINT SURVEY

First Baptist Church
101 Broadway Blvd NE
Albuquerque, New Mexico

April 8, 2014
Project No. 14-001

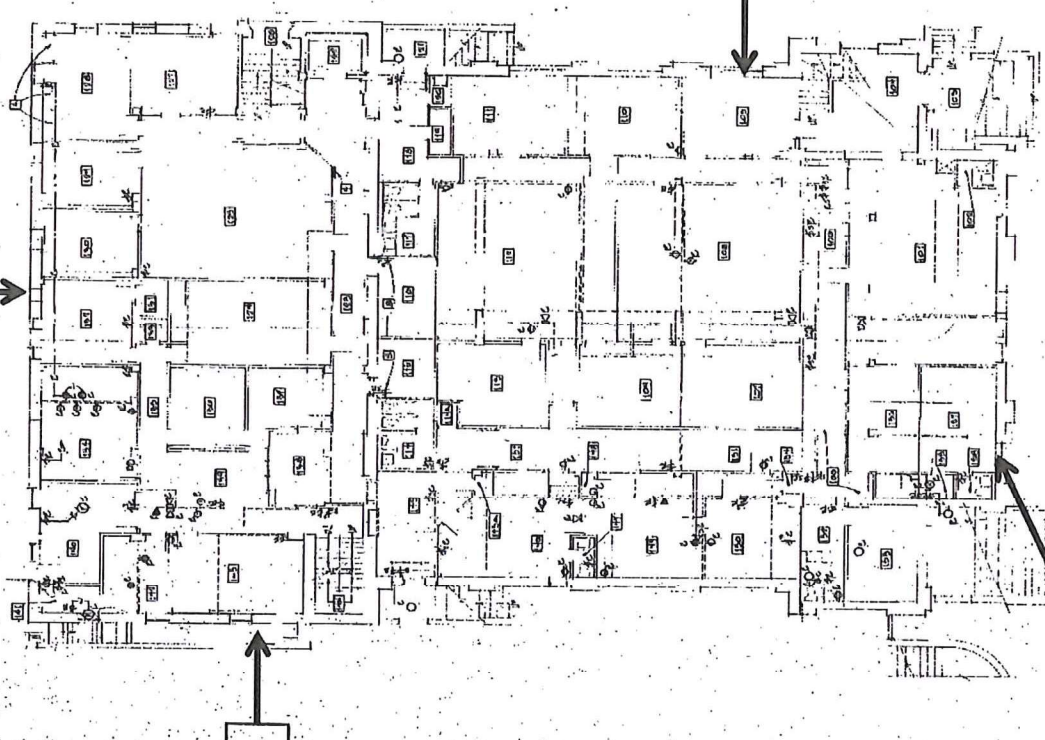
BASEMENT PLAN - EXISTING BUILDING

XRF device samples are depicted by a green arrow.
 Physical lead samples taken are depicted by an orange arrow. At 0.2%, all lead samples taken are within regulatory guidelines. All lead samples had concentrations of less than 0.2%.
