**Phase I Environmental Site  
Assessment Final Report**  
for the  
**Galles Chevrolet Car Storage Lot**  
Albuquerque, New Mexico

July 10, 1998

Project No. 9849.31 F

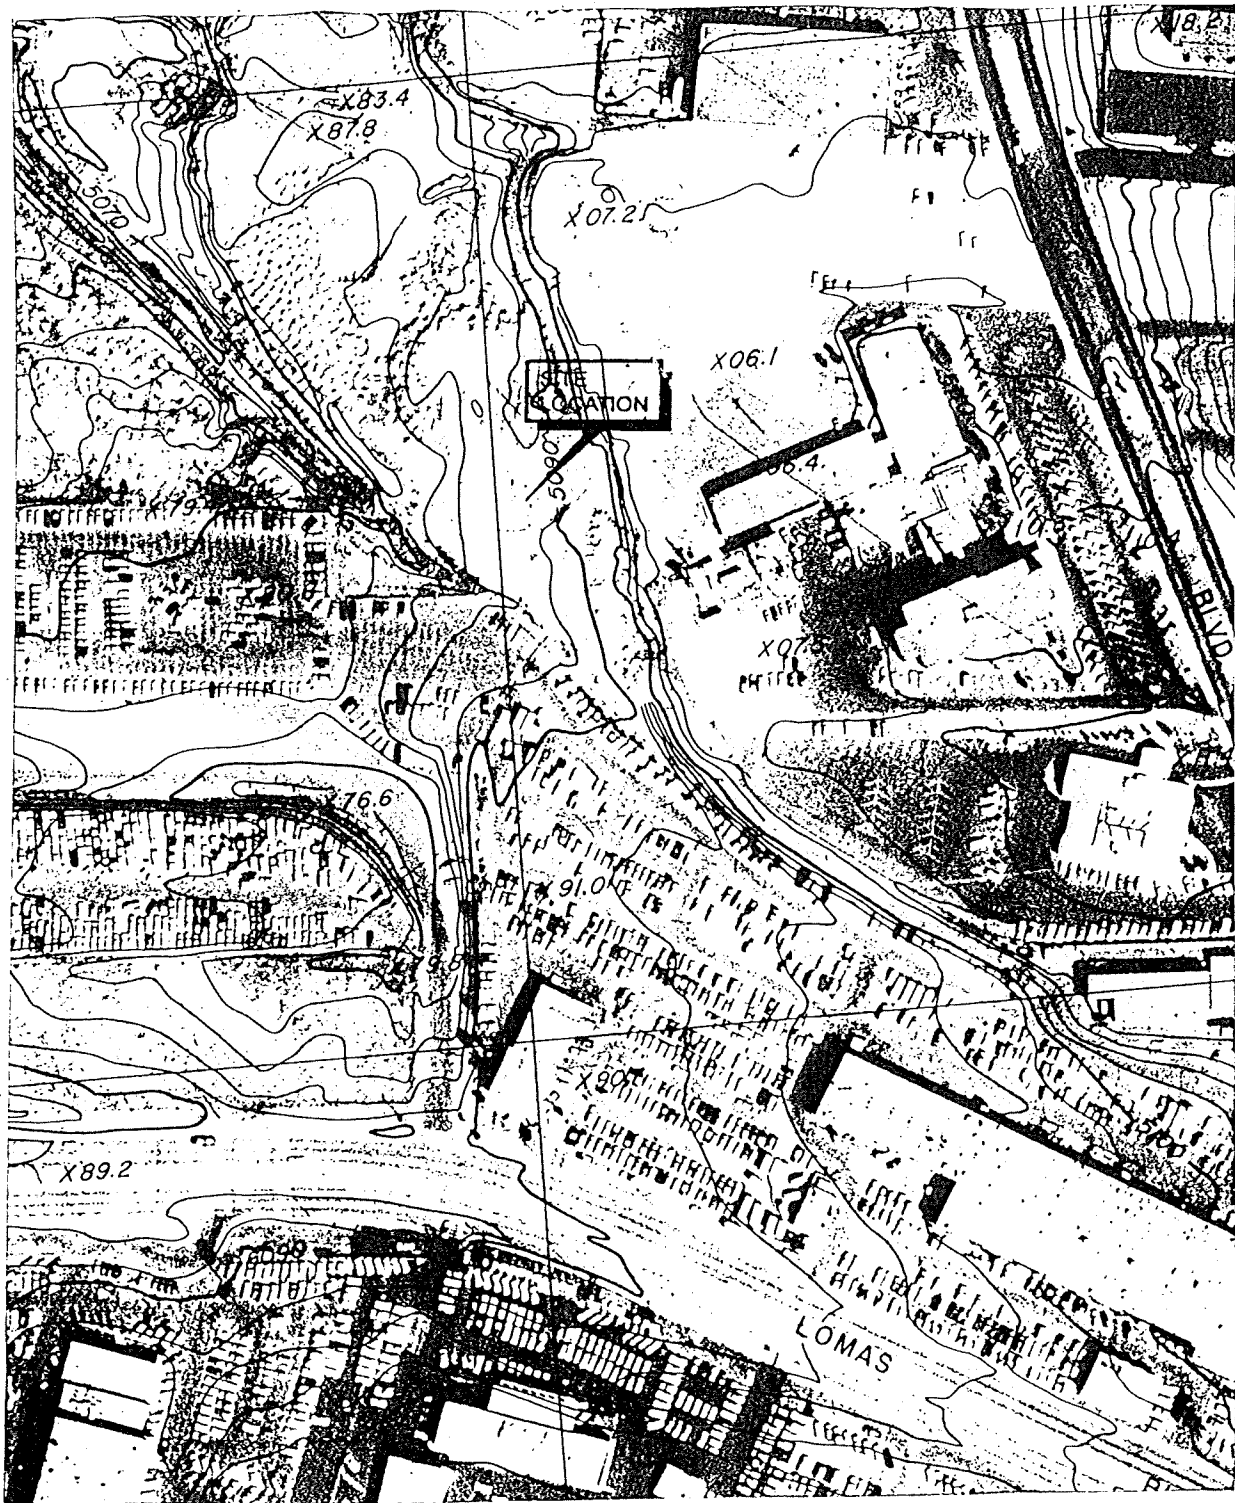
1975 Aerial Photograph

The **1976** aerial photograph depicts the subject site as vacant undeveloped land. The adjacent properties also appeared similar to the ones noted at the time of the on-site inspection, with exception to the parcel located to the northeast which appears to be vacant undeveloped land.
